NO.: 21-025
DATE: February 11, 2021
TO: All Personnel
FROM: Steven Lozano, Deputy Fire Chief, Employee Services
SUBJECT: Incident Review – Groveland Incident

Incident Review

“Groveland” Incident

Tuesday, January 26, 2021

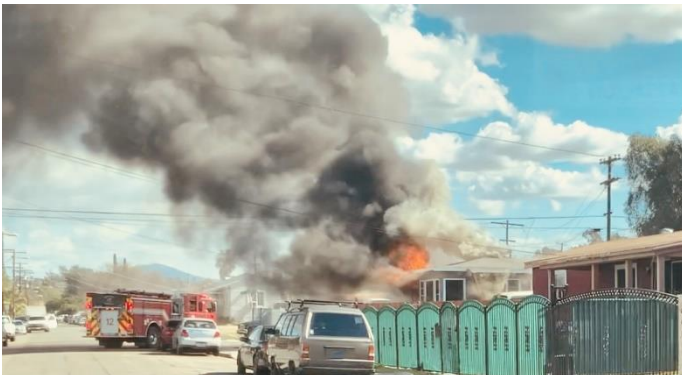
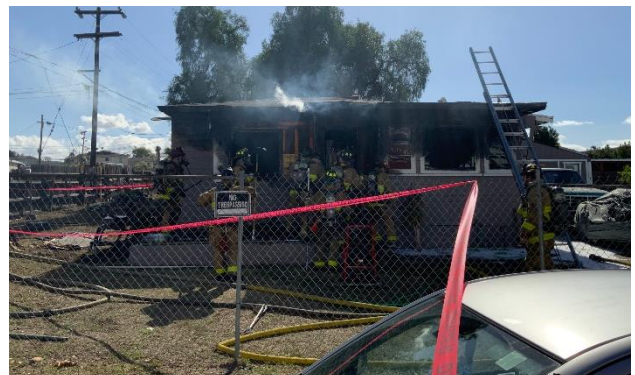
PHOTOS / VIDEO

- The overhead wires were subject to extreme heat from a flashover just prior to units arriving. The heat burned the utility service line that ran to the ALPHA/BRAVO corner of the 1 story roof.
- SND E12 FF (recognizing the need for bolt cutters to gain entry to the residence) initially turned to retrieve them off the Engine, then made the decision to retrieve them from SND T12. The decision helped him narrowly escape an arcing electrical down line falling due to fire conditions. Arcing several times, it came to rest on the metal fence, a parked car and spanned the street between SND E12 and SND T12 potentially charging the chain-link fence.
