BULLETIN

NO.: 21-143
DATE: August 31, 2021
TO: All Personnel
FROM: Steven Lozano, Deputy Fire Chief, Employee Services
SUBJECT: Green Sheet – Cal Fire Rancho incident – CNG Cylinder Failure

GREEN SHEET

Commercial Vehicle Fire

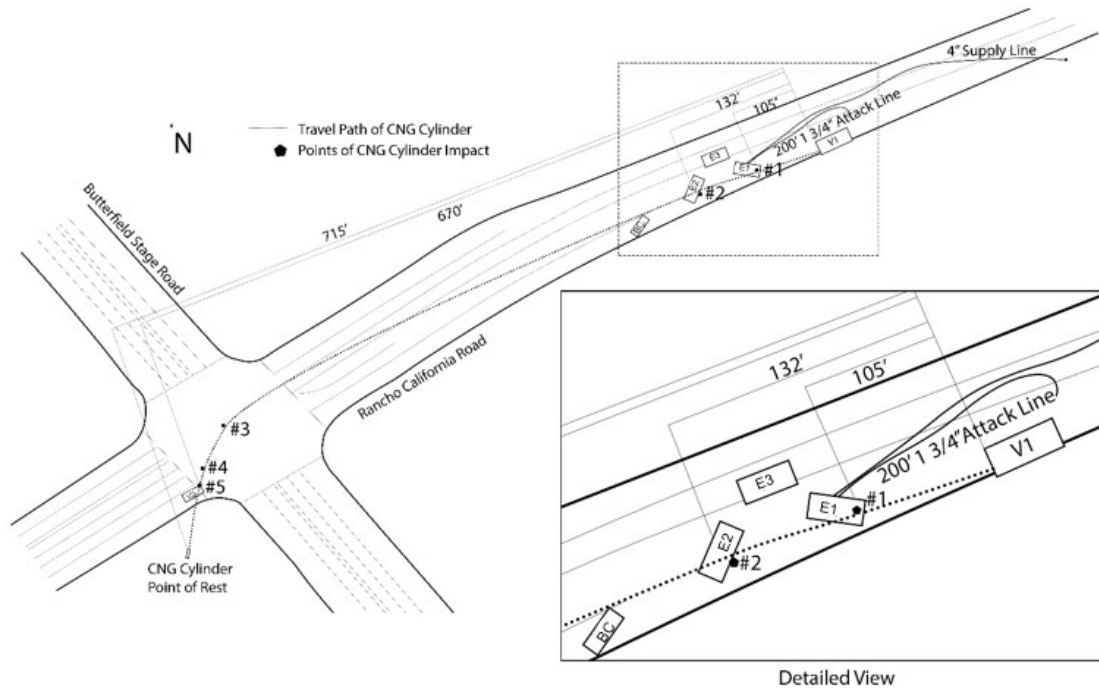
- Proper placement of E1 and E2 minimized the impact to oncoming traffic, deflecting the cylinder's route of travel.

Diagram of incident location

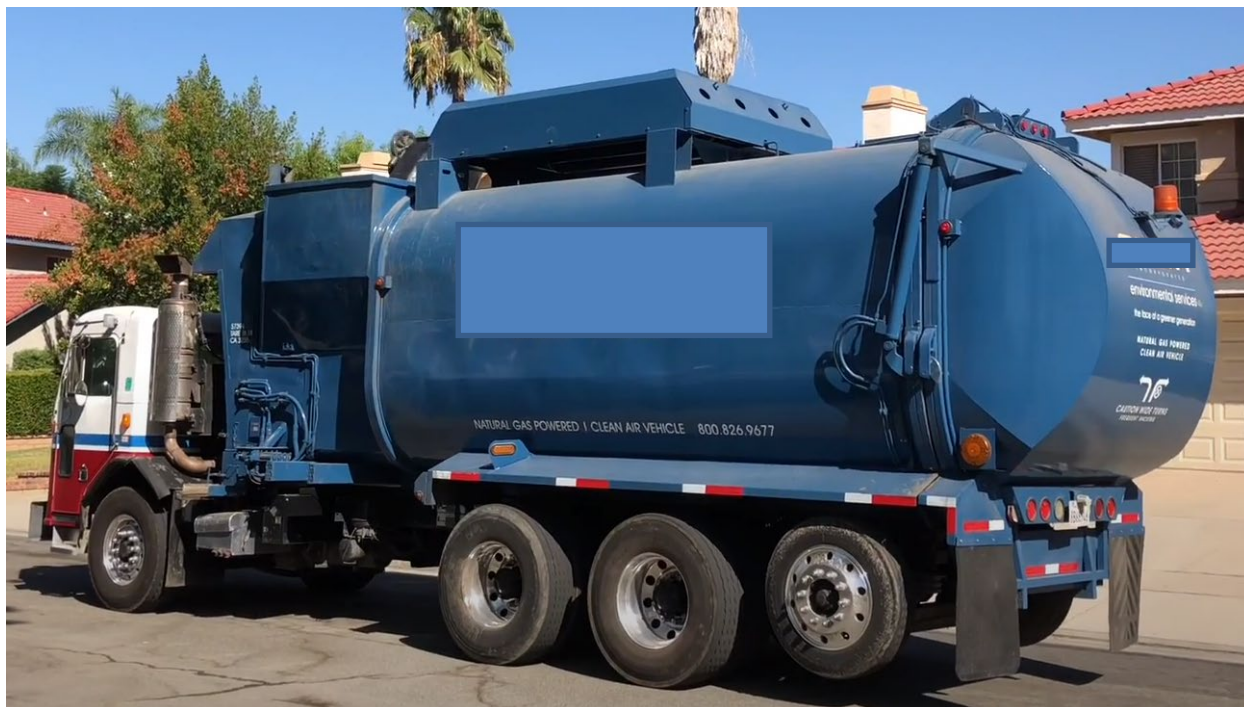
View of a similar truck without damage. Holes on the cylinder cover can indicate orientation of cylinders

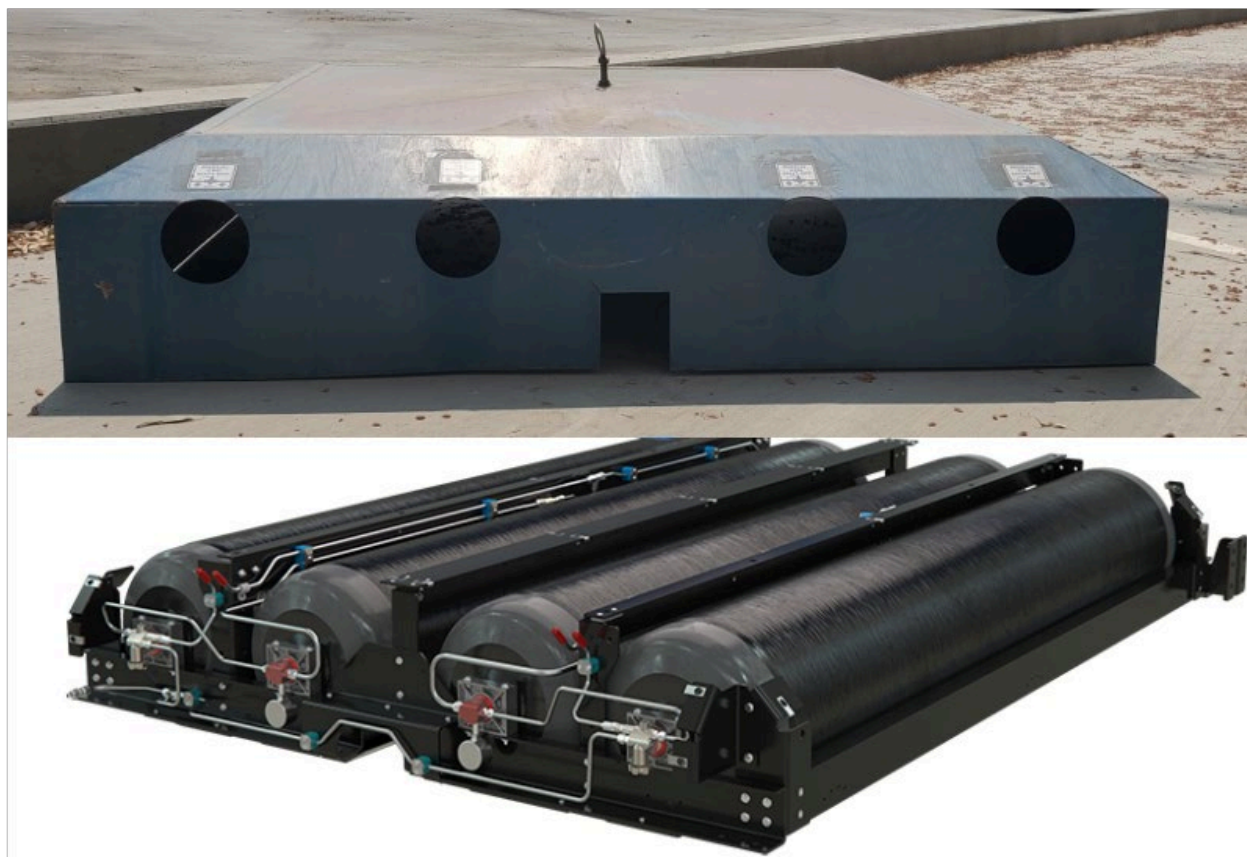
View of typical roof-mounted cylinder configuration and cylinder cover from similar Trash Truck. Cylinder cover size is 78"L x 85"W and approximately 200lbs. Single cylinder size is 77"L x 16" diameter and 153lbs.

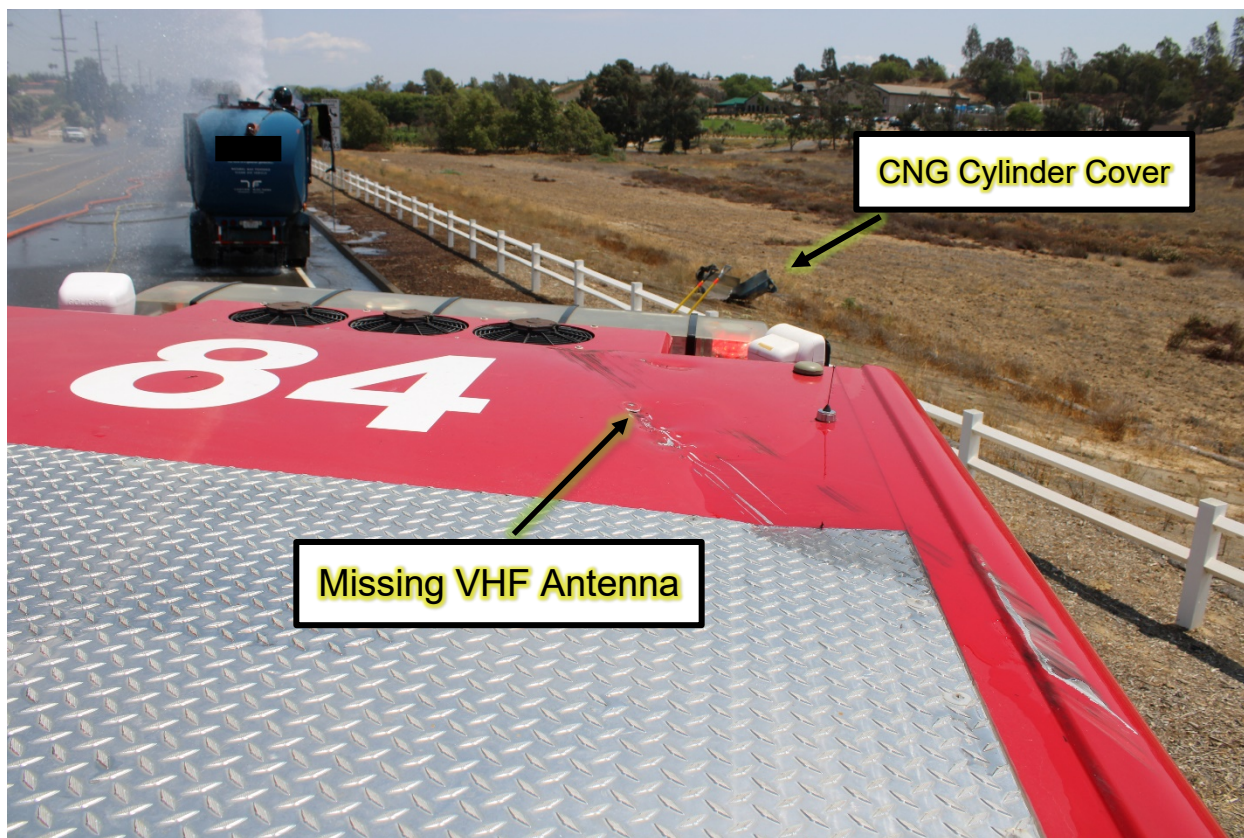
E1 sustained moderate damage to the cab roof.

View from cab roof of E1

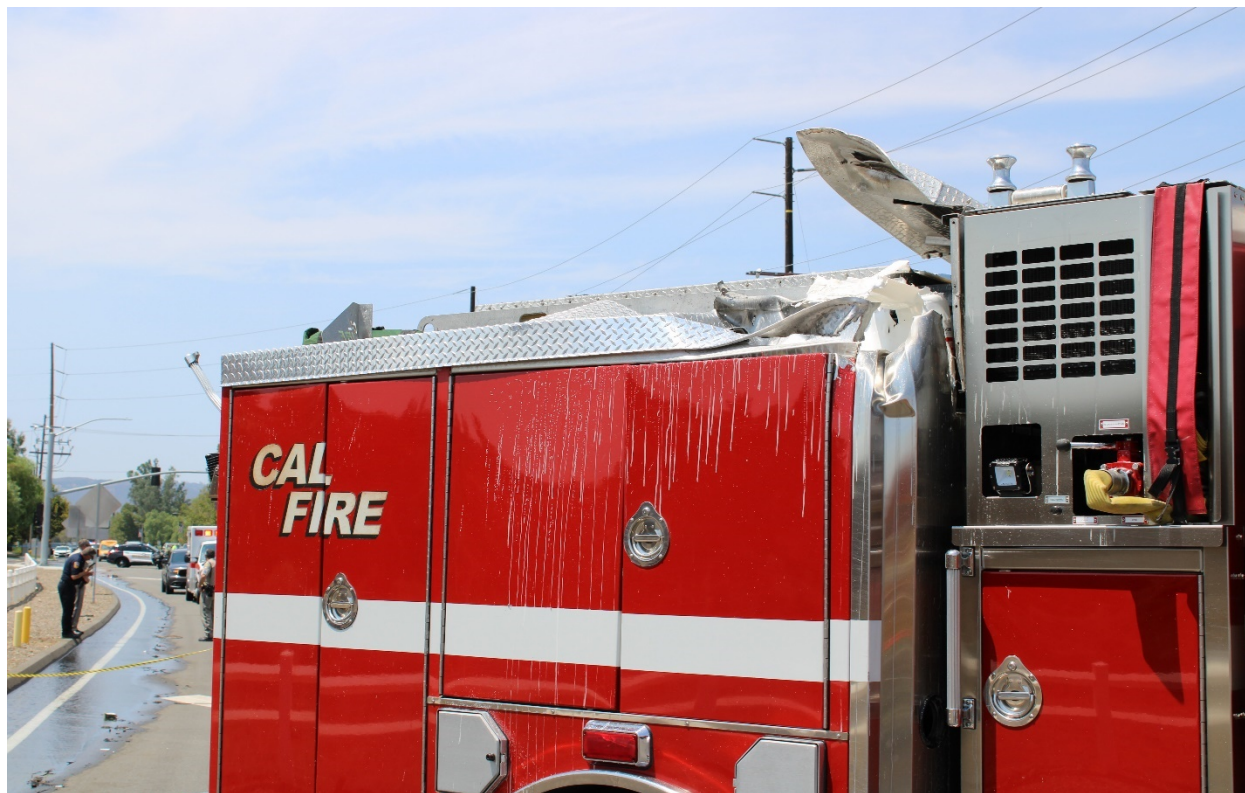
E2 sustained major damage to the fire body.

View of damage to E2 from ground level

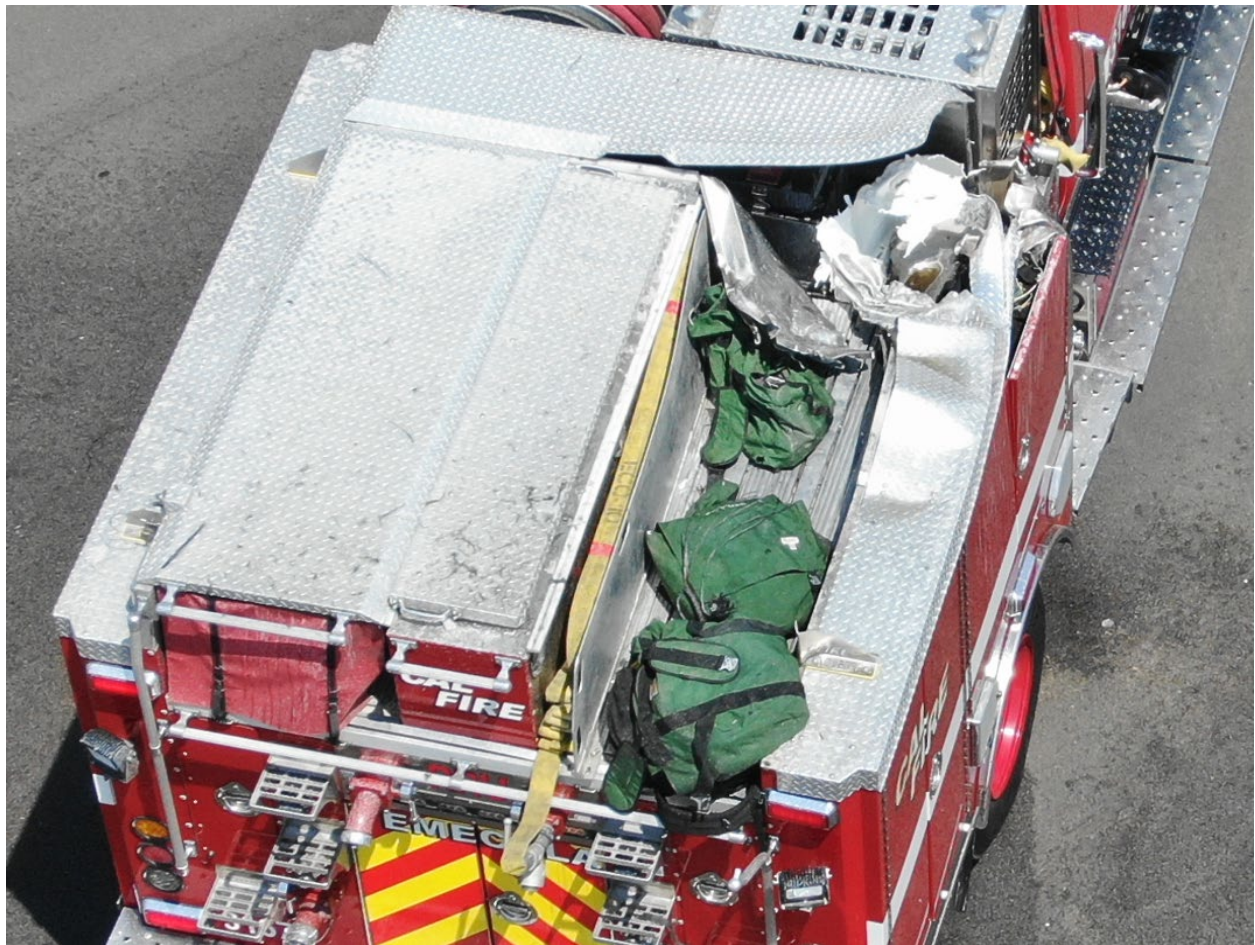
View of damage to E2 from above

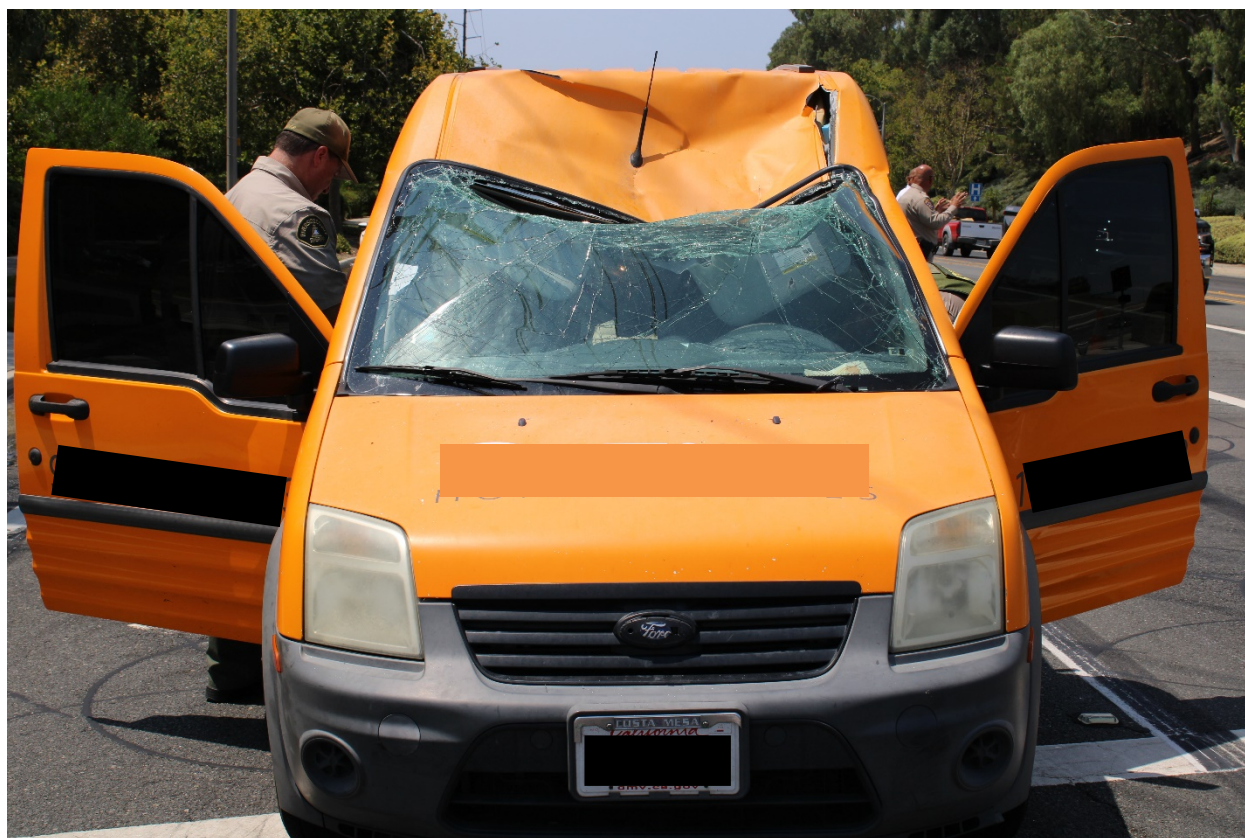
V2 sustained major damage to the roof and body.

View of damage to V2

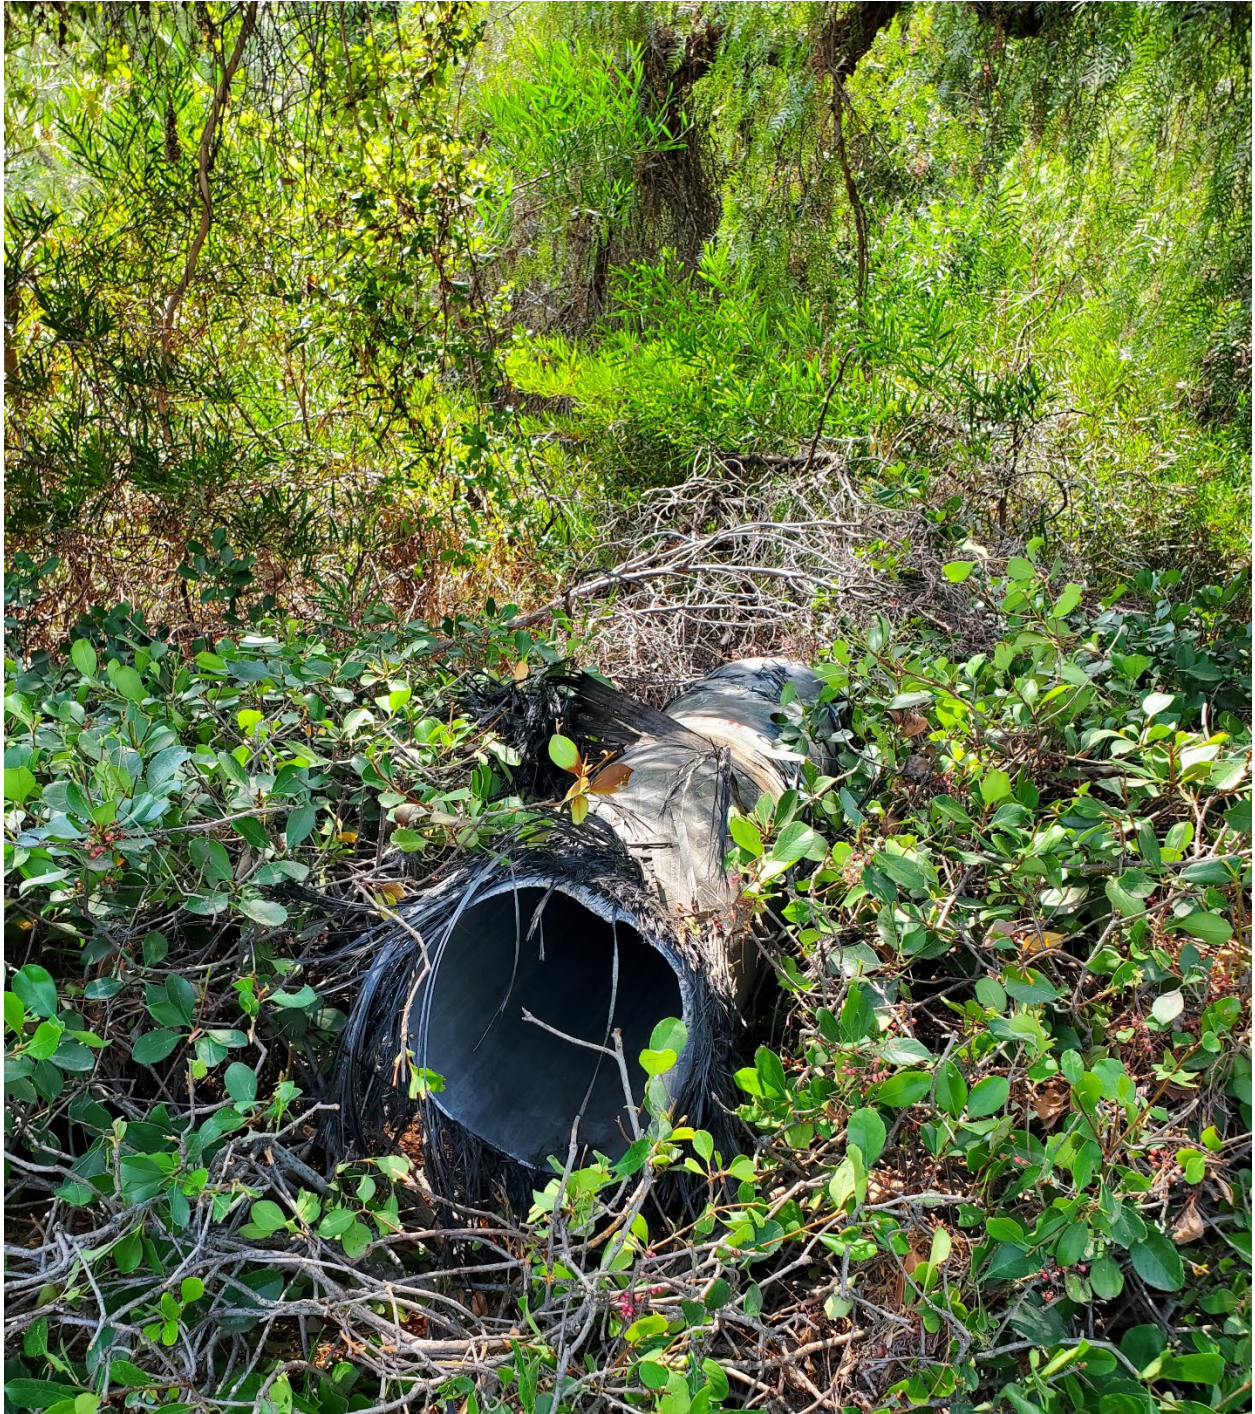
Within 60 seconds of water application, one of the four roof-mounted compressed natural gas cylinders failed. The resulting blast blew the cylinder cover off V1 and into an adjacent field. The cylinder then flew from its mounting location on top of V1 (estimated speed of travel 450 MPH), approximately 105 feet, striking a glancing blow across the right-side roof of E1, and destroying the VHF radio antenna. FC1 was in the right front seat at the time of impact. The cylinder continued in the air approximately 27 feet, striking the passenger side hose bed of E2, ripping the hose bed wall and cover from the fire body. The cylinder then tumbled mid-air, approximately 538 feet from V1, where it bounced twice in the intersection, before striking a light-duty commercial vehicle (V2) and came to rest in bushes on the south side of Rancho California Road. FC1 attempted to contact the Perris ECC on RVC CMD1 via E1's mobile radio but was unable to get out due to the detached antenna that he was unaware of. FC1 switched to their handheld radio and notified the ECC of Emergency Traffic.

View of cylinder at point of rest

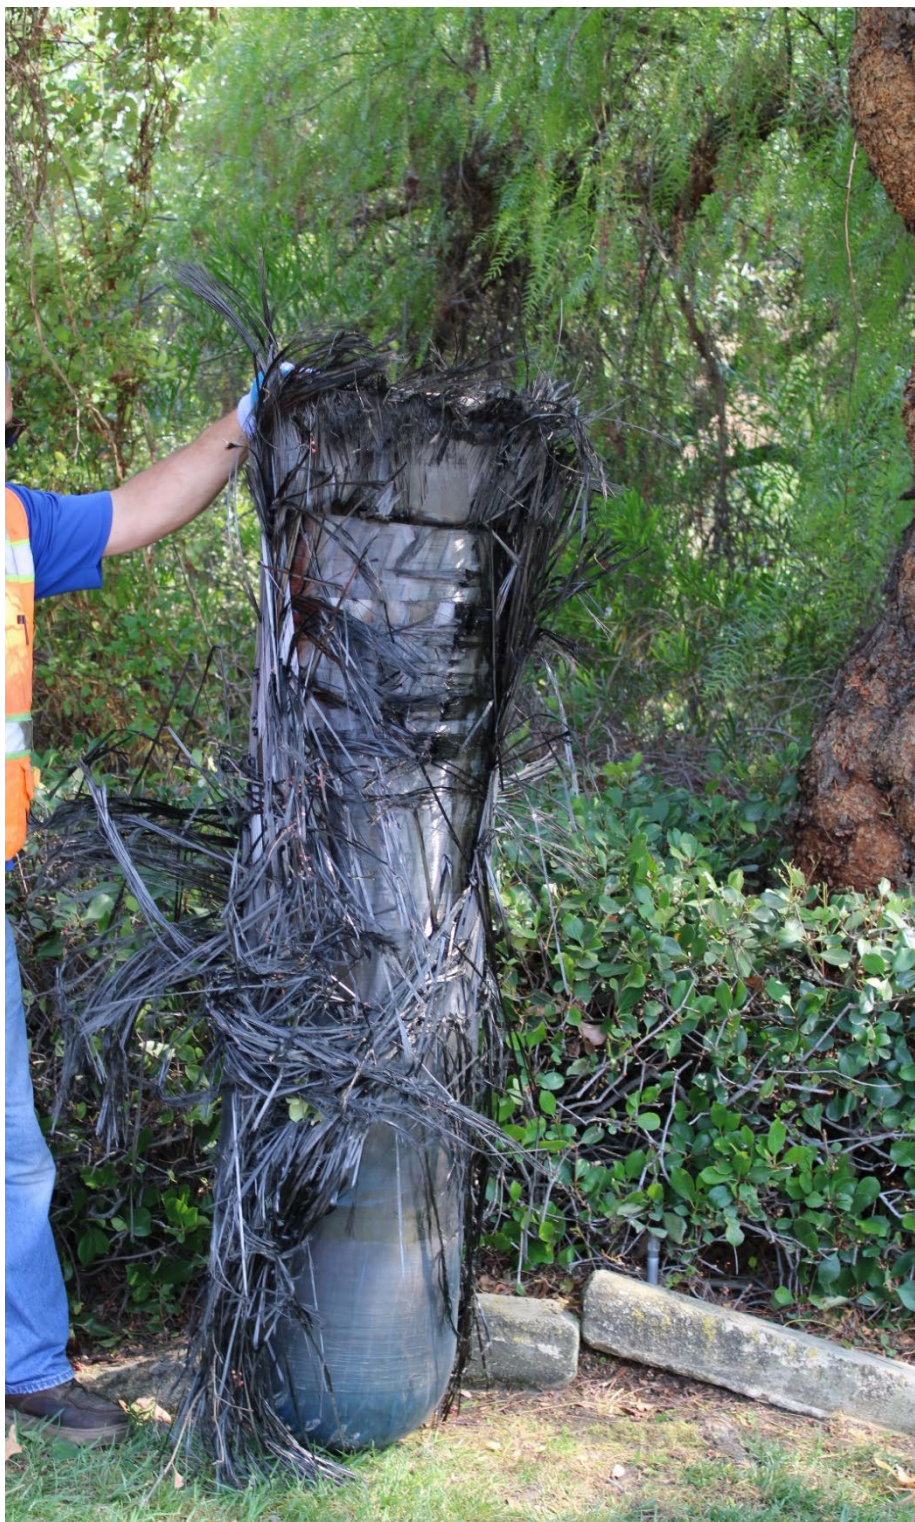
- Factors such as maintenance/cleaning, design flaw, mechanical failure, and thermal cooling (result of suppression efforts cooling the TPRD) were evaluated and only thermal cooling could be ruled out as causal factor.

View of cylinder held upright

- CNG cylinders do not pose a BLEVE threat.
- DO NOT apply water to CNG cylinders as this may prevent the Thermal Pressure Relief Device (TPRD) from activating and releasing pressure within the cylinders.
