NO.: 21-145  
DATE: September 9, 2021  
TO: All Personnel  
FROM: Steven Lozano, Deputy Fire Chief, Employee Services  
SUBJECT: Green Sheet - Commerce Incident – A/C Unit through the Roof - Near Miss

# Informational Summary Report of Serious or Near Serious Injuries, Illnesses and Accidents

**Commerce Ave. Incident/ FS21092441**  
**Air Conditioner through the Roof - Near Miss**  
Thursday, June 17, 2021

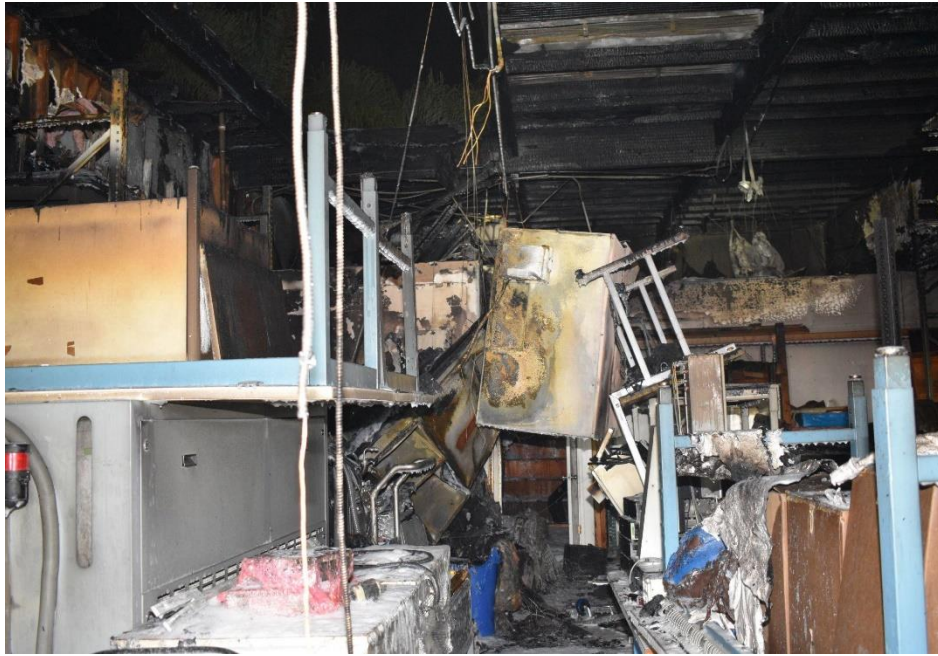
- SND E41 firefighter notices an unstable A/C unit and notifies the SND E44 Captain inside the building
- A Large A/C unit falls from the roof due to structural compromise of the brackets holding the unit in place from direct flame impingement

The building is divided into two suites, one and a half stories high and constructed of noncombustible masonry with a panelized flat roof that contains exposed purlins, beams, and rafters. Two commercial HVAC units are located on the rooftop where one HVAC unit collapsed into Suite A during suppression efforts. Both HVAC units were located adjacent to 4 X 8 skylights. The proximity of the skylights was a contributing factor to the collapse of the HVAC unit.

Fire progressed through convective heat transfer, a smoke and gas layer developed as well as a ceiling jet. Simultaneously, active burning continued from the area of origin in the south warehouse, concentrating convective and radiative heat flows to the ceiling directly above. A 4 X 8 skylight, located adjacent to the south central area of origin, was determined to have failed during fire progression. Skylight failure was a result of exposure to accumulated hot gases and radiant heat. Once the skylight failed, a single vent opening for hot smoke and gases to escape was created. The fire was fuel controlled and did not transition to ventilation controlled due to the single vent opening. The single vent opening allowed for localized intense burning in and around the skylight where fuel - air mixing was optimal. This caused weakening of the structural members of the adjacent HVAC system.

**Interior, noted A/C unit (center, suspended)**

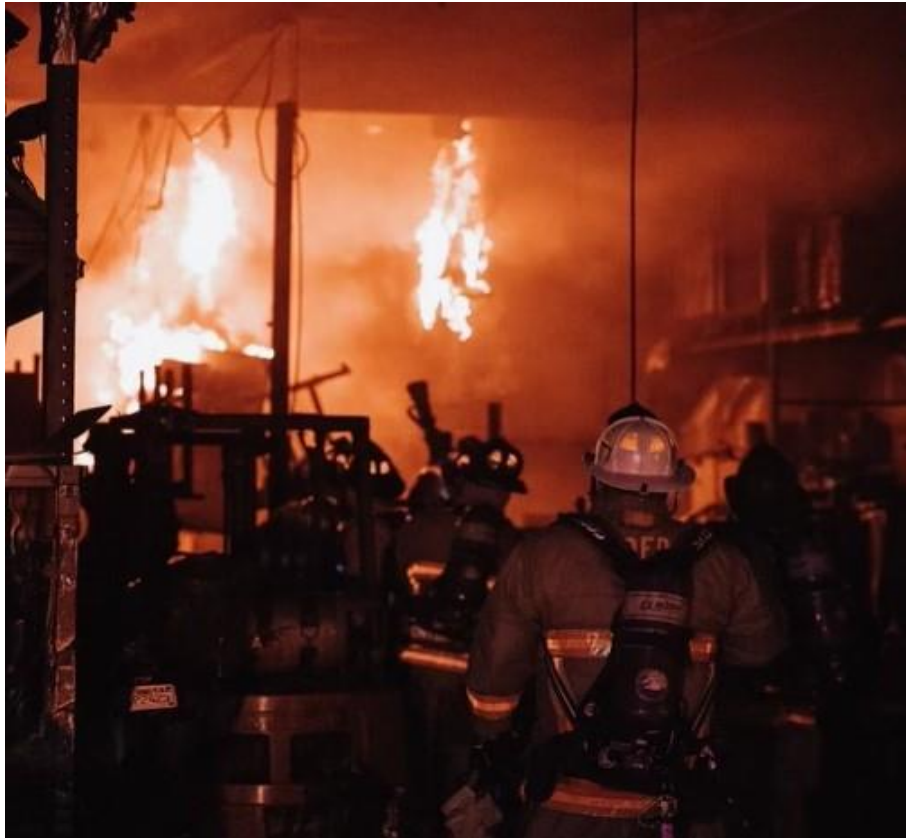
**Interior, Charlie side**

**(Note: Left side, center is the A/C unit falling, just left of the pillar)**
