NO.: 23-040
DATE: March 7, 2023
TO: All Personnel
FROM: Robert Logan, Deputy Fire Chief, Employee Services
SUBJECT: Green Sheet - Poway Rink Incident - Near Miss from a large electrical arc

GREEN SHEET

Poway Fire Department "Rink Incident"

Incident Number - PW22004875
12455 Kerran St. Poway, CA 92064

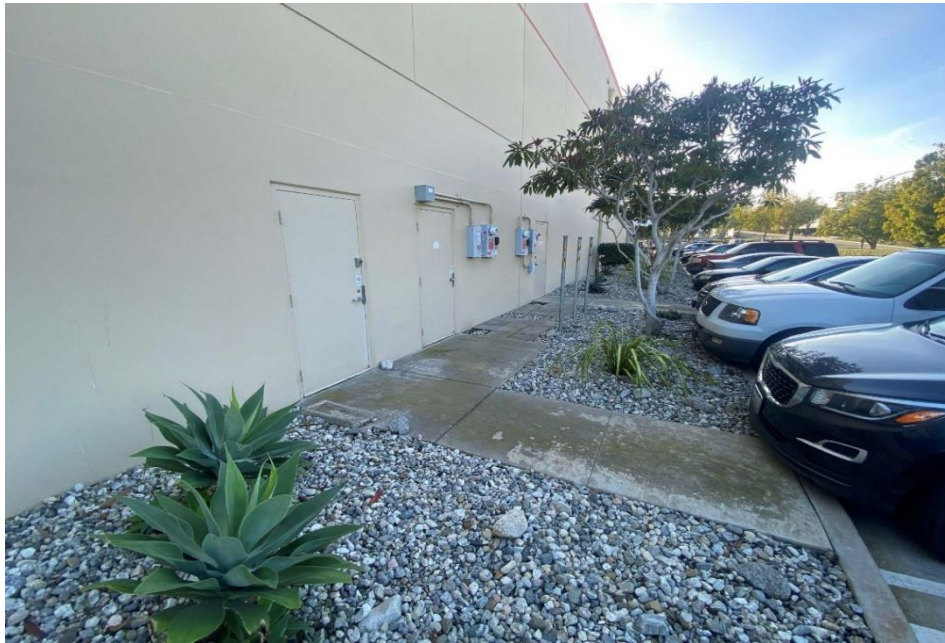
Image 3 - Electrical Room Entrance (Alpha Side of Structure)

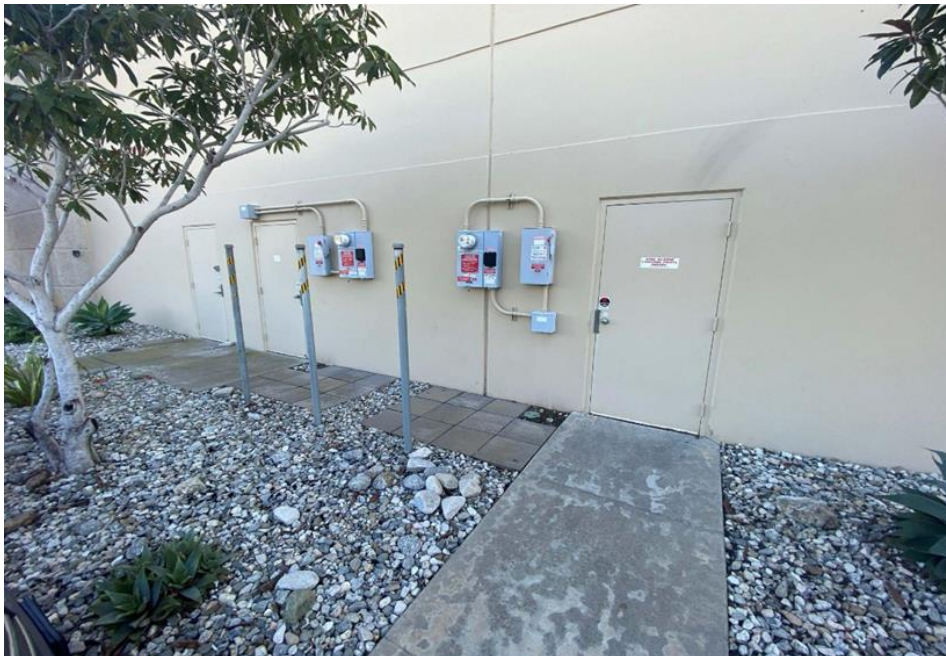
- Mayday on the TAC channel was never transmitted to Metro (ECDC) on the Command channel.
 - Poway Fire Department Manual of Operations - Chapter 15 Subject 4 Communications
- Electrical was thought to be secured.
 - All breakers were switched to the off position; however, the electric meters continued to run, indicating that power was still being produced and not fully secured.
- Be selective with descriptive words, such as “isolated” or “secured,” when relaying information to the Incident Commander (IC).
 - An IC would have reasonably thought that the power to the electrical room had been disconnected and the electrical hazard was no longer present.
- If a solar system is identified, it must be relayed to and confirmed by the IC and secured at each solar disconnect (see Image #4).

Image 4 - Electrical Room Entrances with Solar (PV) Meters and Shut Offs

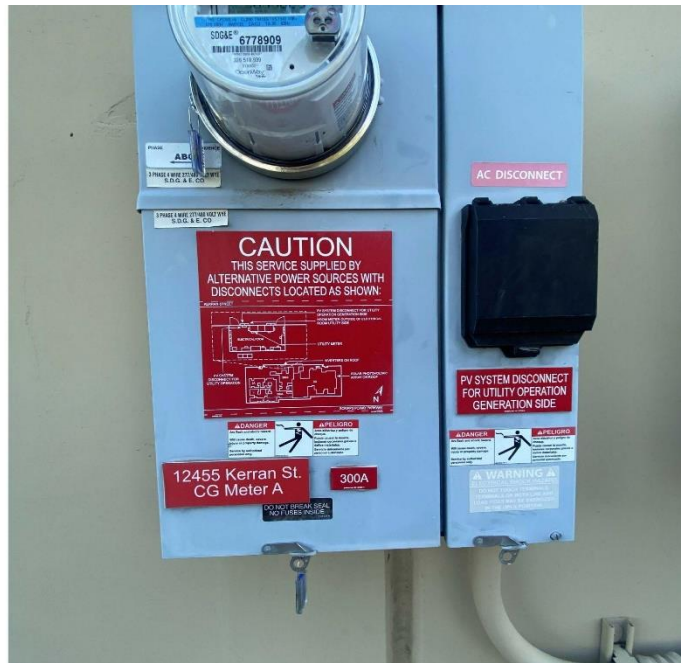
Image 5 - Solar (PV) Meter

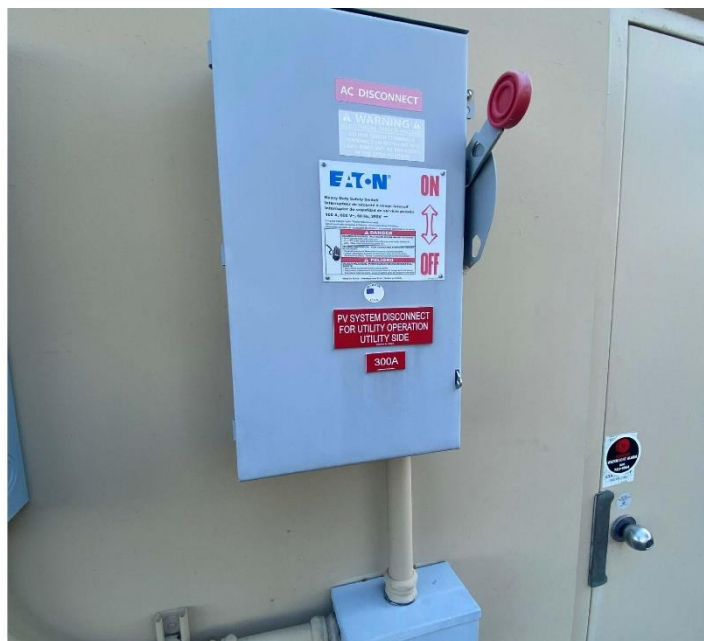
Image 6 - Solar (PV) Disconnect

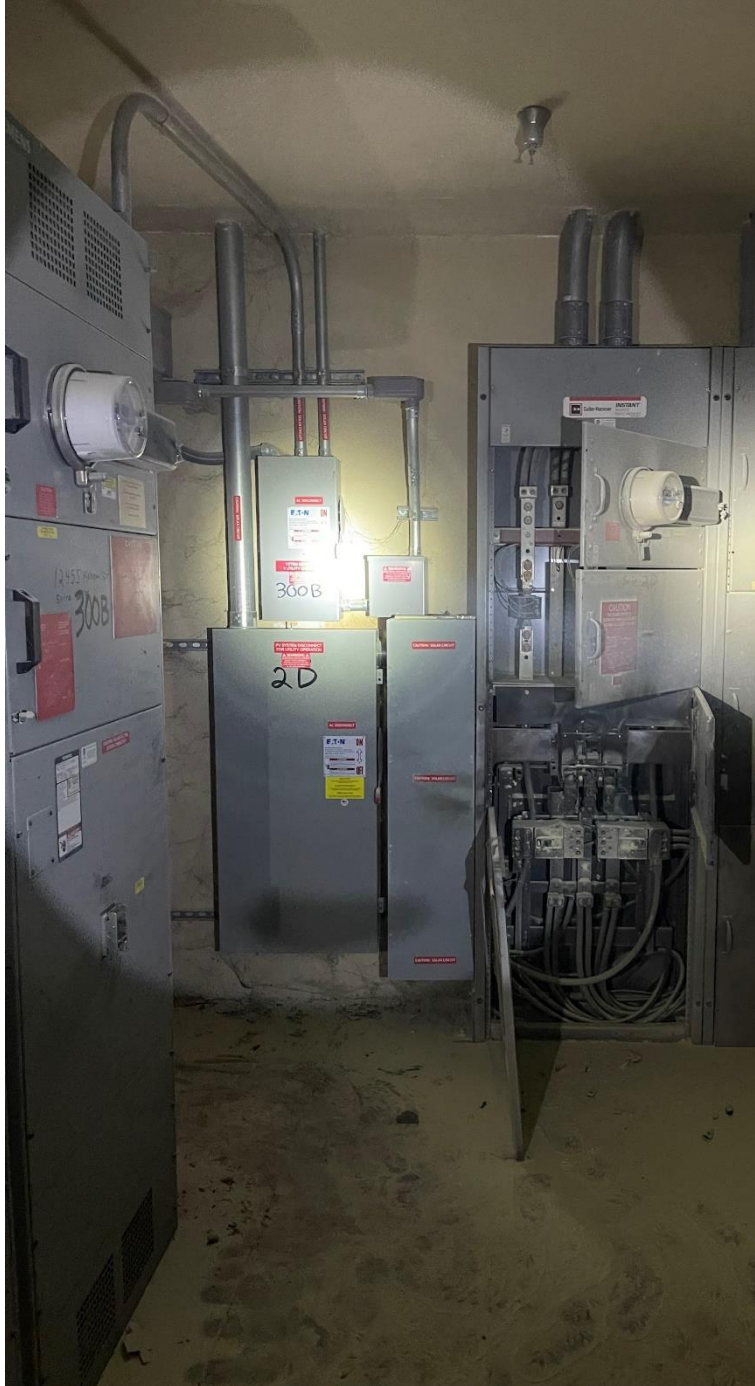
- No fire was noted
- The electrical room (room of origin) charged with smoke upon arrival of first in crew
- Three (3) electrical arc flashes occurred

16:50-16:55 - Electrical arc flashes occurred within the building's electrical room.

Image 7 - Electrical Room (Interior), Damaged Electrical Panel

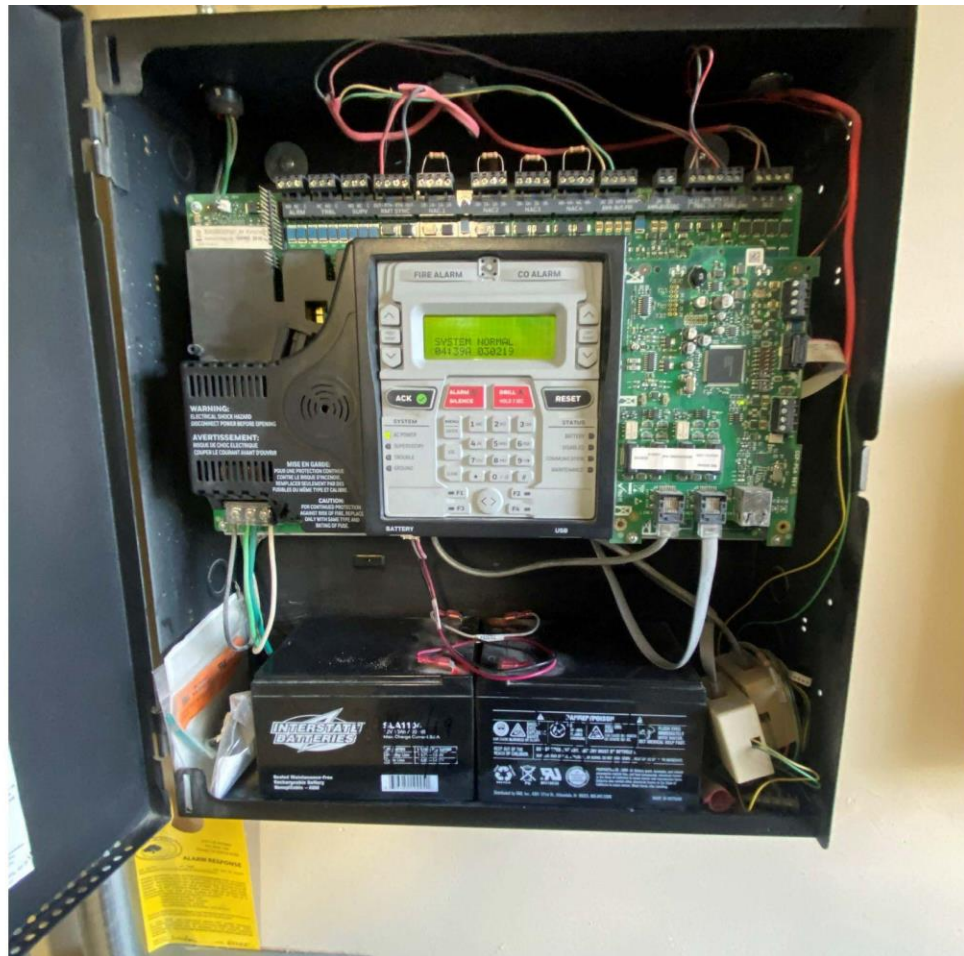
- ***The building's alarm panel was located inside the involved electrical room.
 - POW T93 crew members stowed their aerial ladder while the company officer proceeded to the electrical room to check the building's electrical panel.

Image 8 - Fire Alarm Panel (Located Inside Electrical Room)
