BULLETIN

NO.: 22-088
DATE: June 7, 2022
TO: All Personnel
FROM: Robert Logan, Deputy Fire Chief, Employee Services
SUBJECT: Green Sheet – Cal Fire Durango Incident – Firefighter Burn Injury

GREEN SHEET

Durango Structure Fire

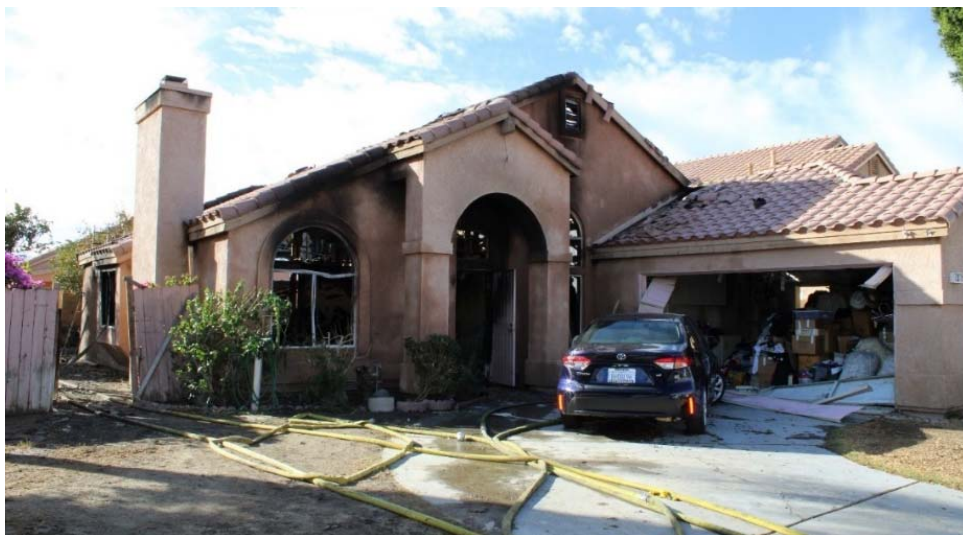
Photo 1: The A-Side of the structure and point of entry through the front door.

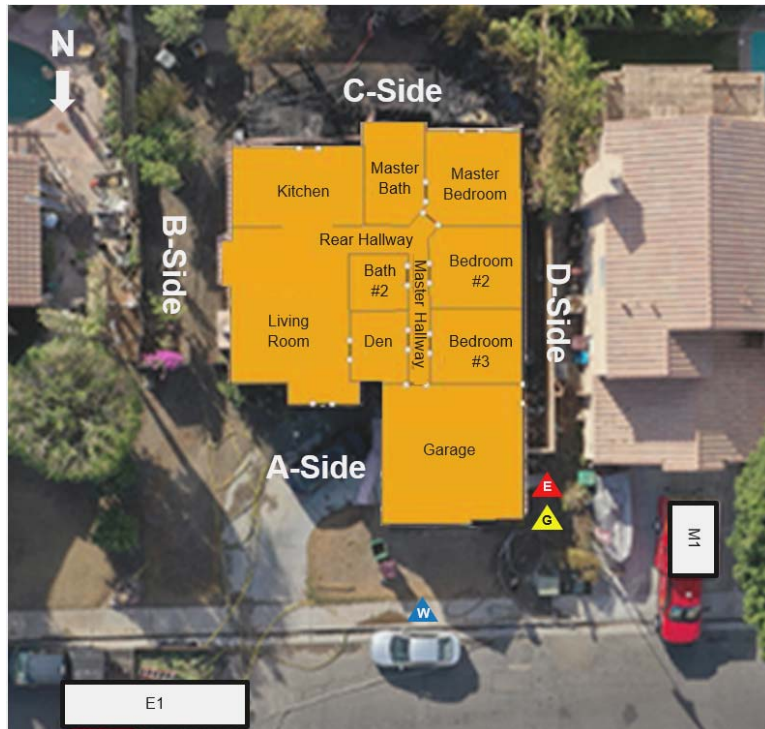
Photo 2: Floorplan of the structure

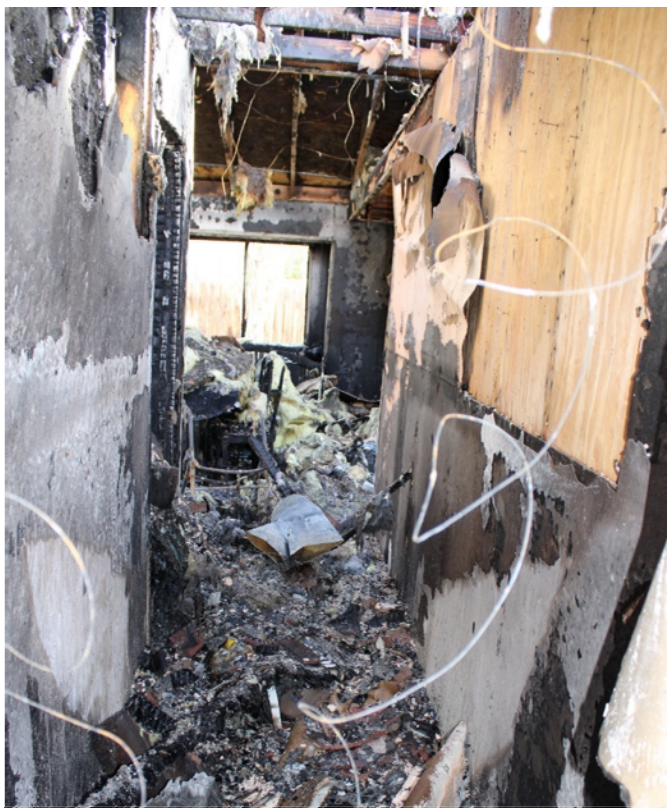
Photo 3: View from master hallway looking towards C/D corner

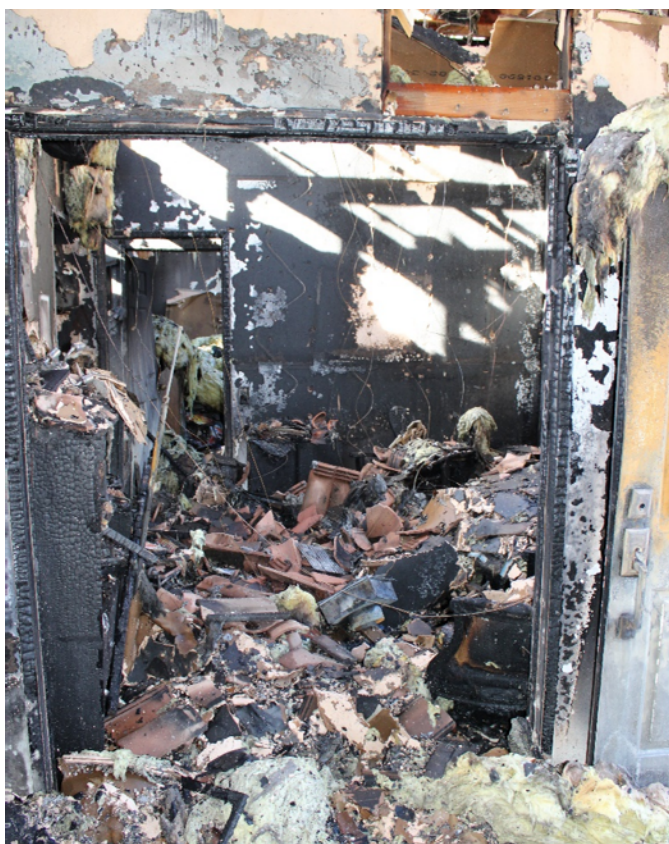
Photo 4: View from the living room at front door looking through den towards master hallway

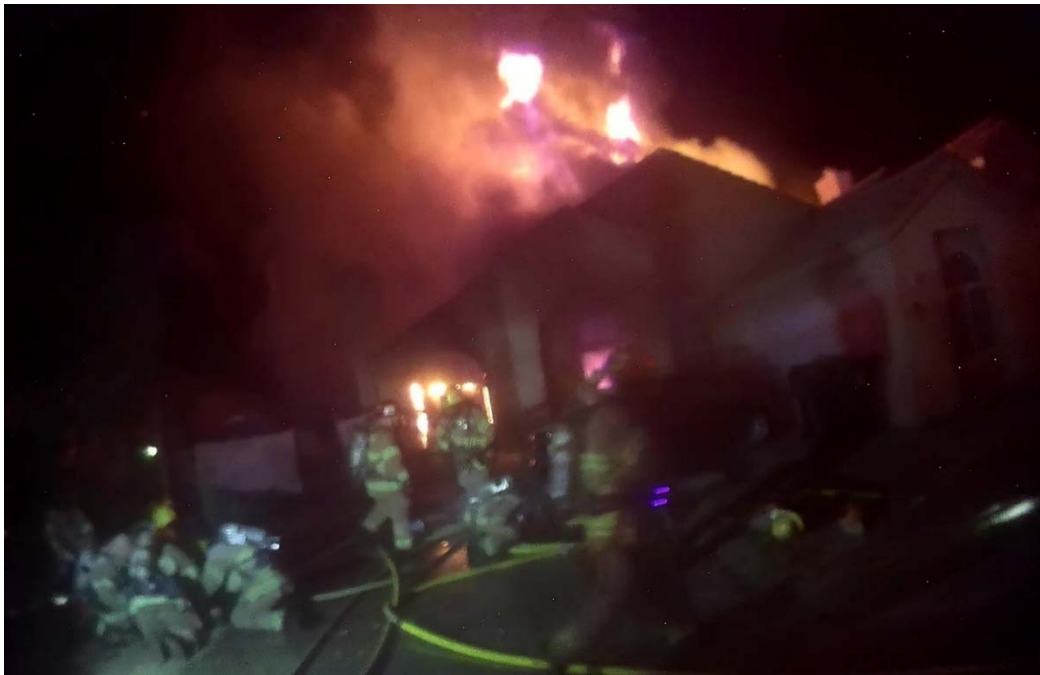
Photo 5: Fire conditions moments after all firefighters exited the structure

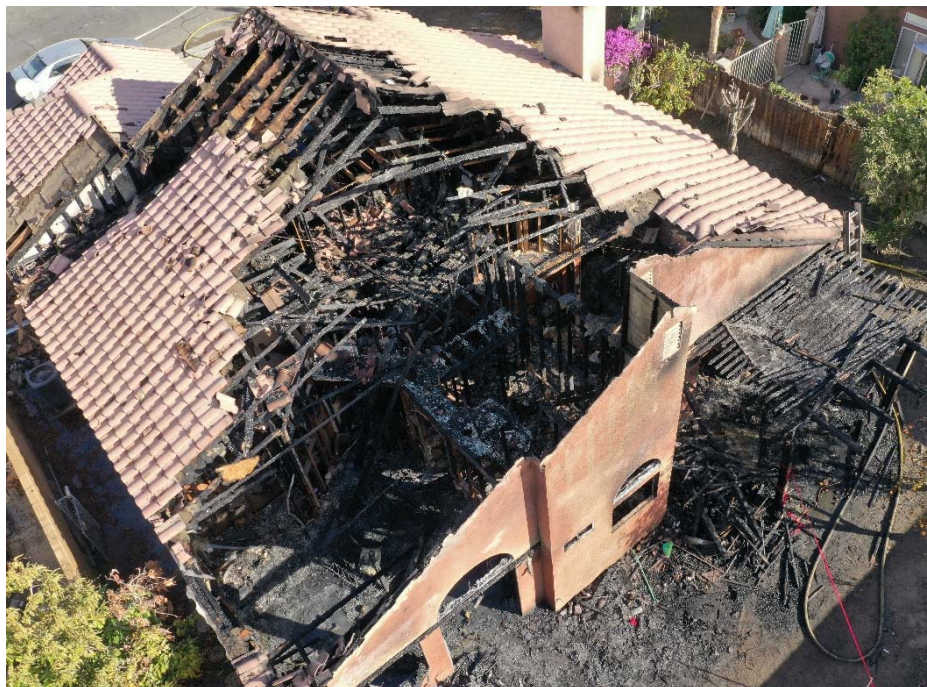
Photo 7: Aerial view of C/D corner of the structure

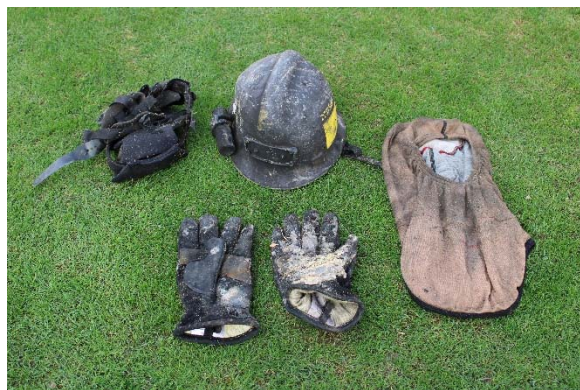
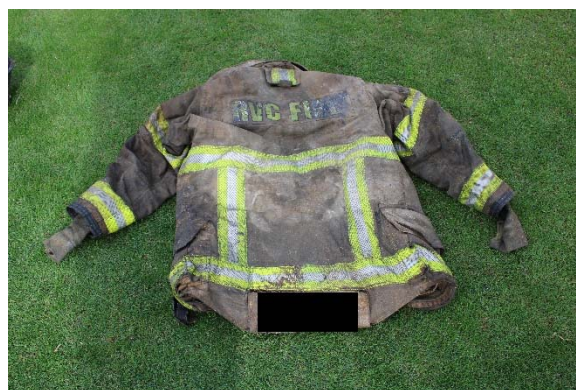
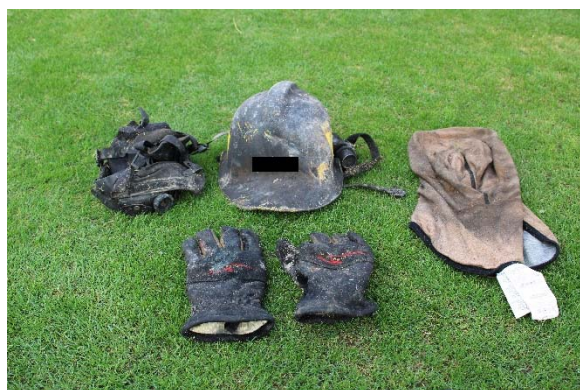
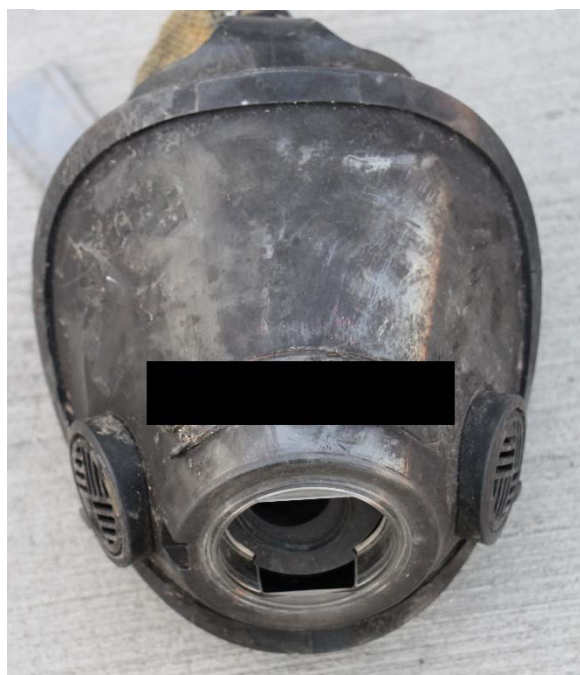
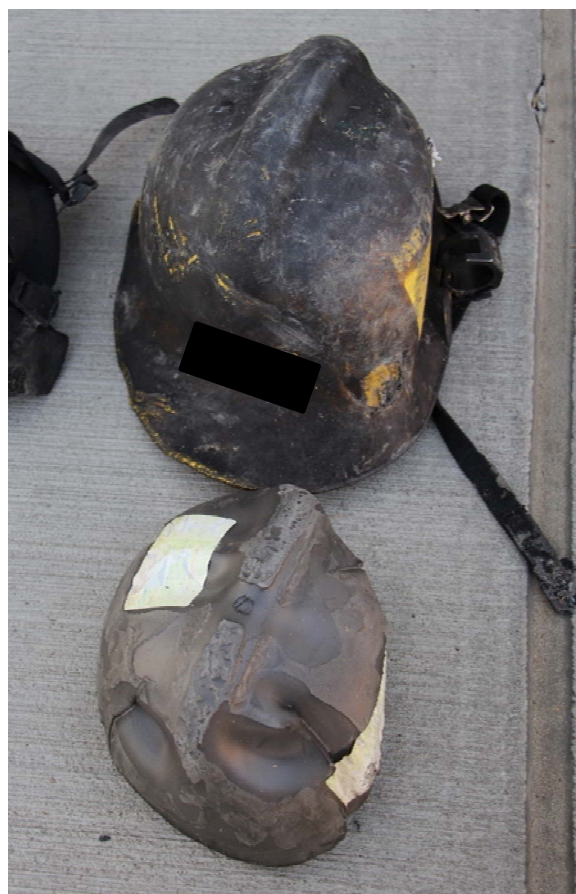
- FF1 suffered first, second, and third-degree burns covering approximately 38% of the body including the neck, shoulders, abdomen, forearms, hands, one knee, and one foot.
- FC2 suffered second-degree burns covering approximately 1% of the body including the head, neck, and back.
- FAE3 suffered a musculoskeletal injury to the right knee.
- FF6 suffered a smoke inhalation injury.
- FC3 suffered a smoke inhalation injury.

Photos 8-12: PPE of FF1

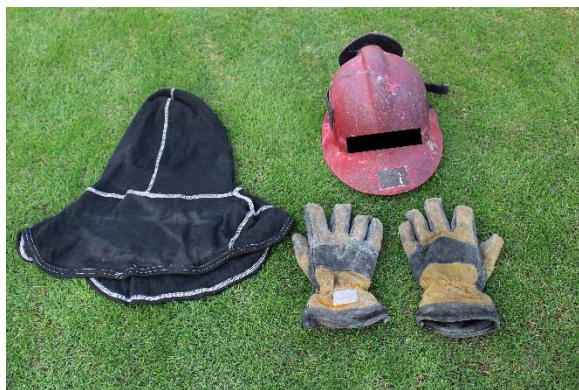
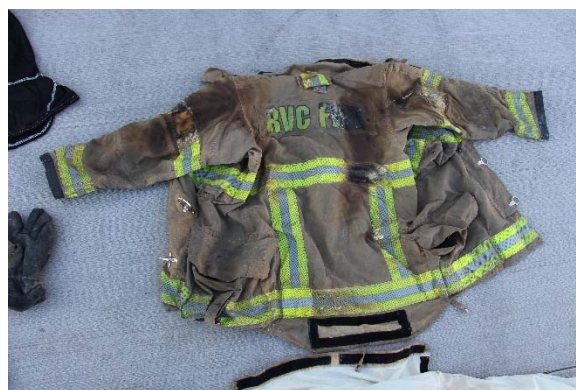
Photos 13-14: PPE from FC2

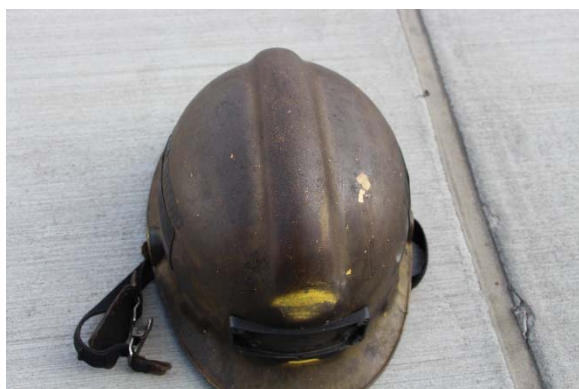
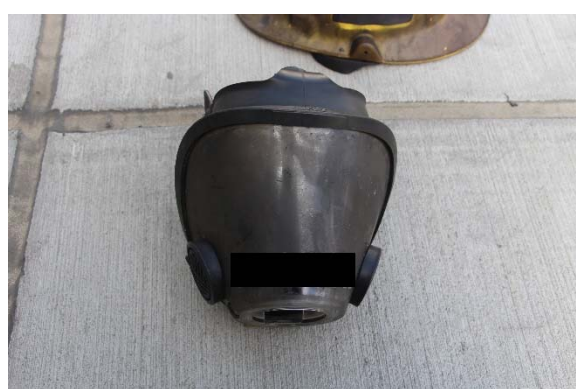
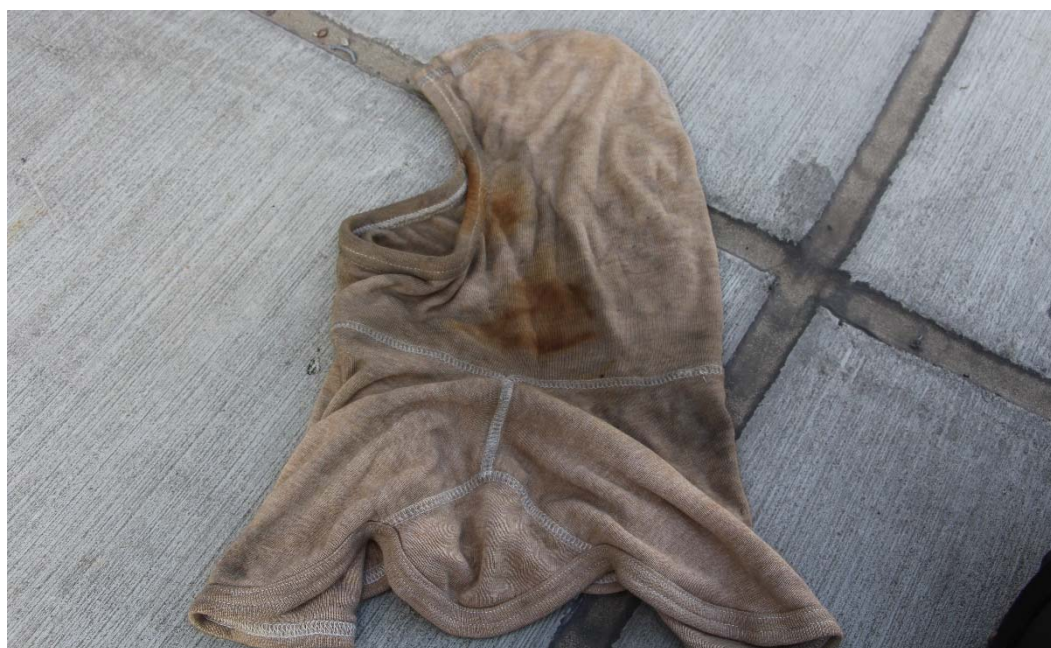
Photos 15-17: PPE of FF2

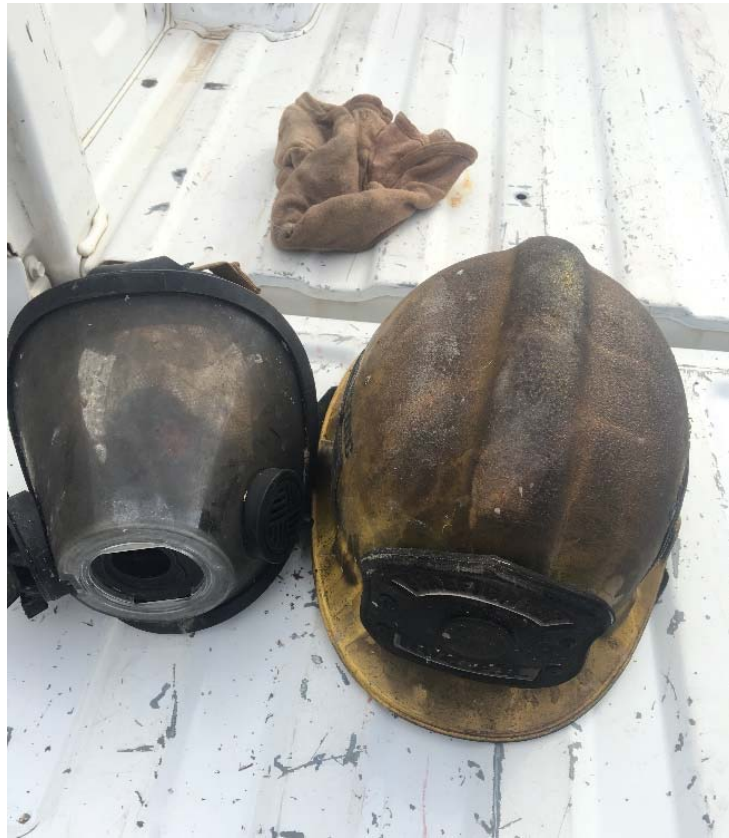
Photo 18: PPE of FF3

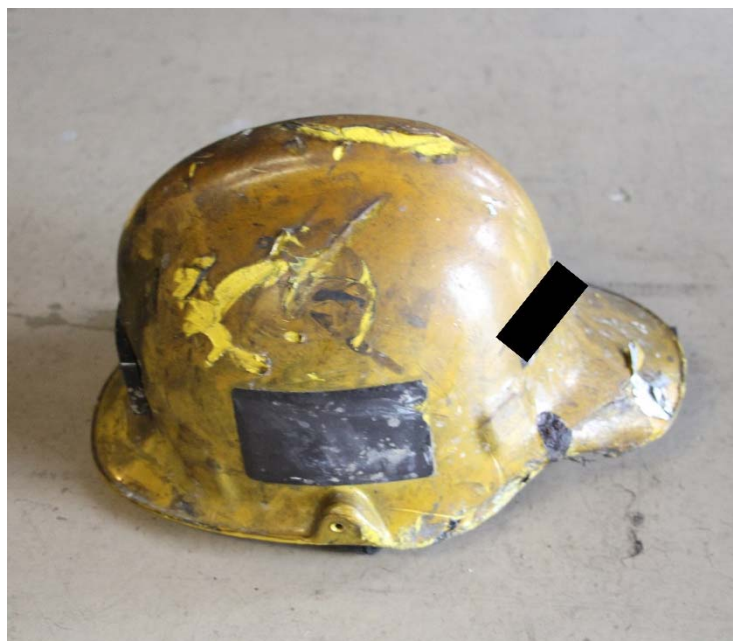
Photo 19: PPE of FAE3
