Informational Summary Report

Incident Review

San Diego Fire-Rescue Department

“Clairemont IC” Incident # FS22113169

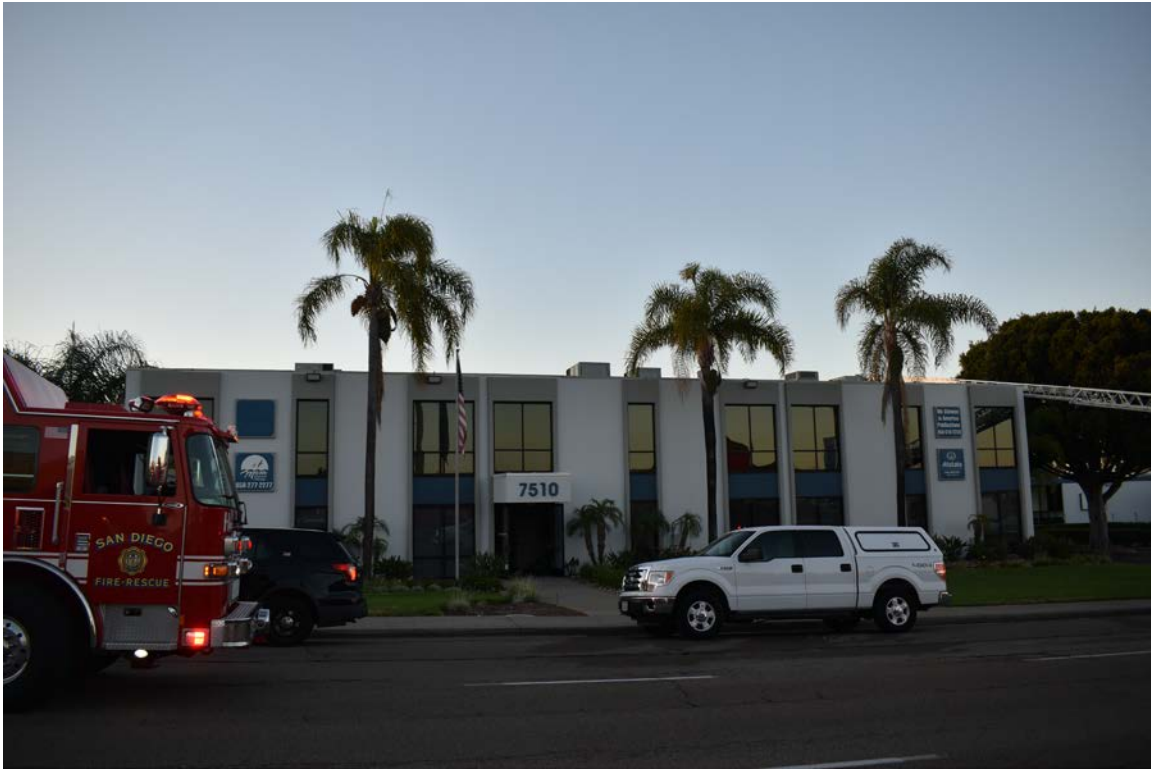
Photo No. 1: Alpha side of two story commercial structure with center courtyard.

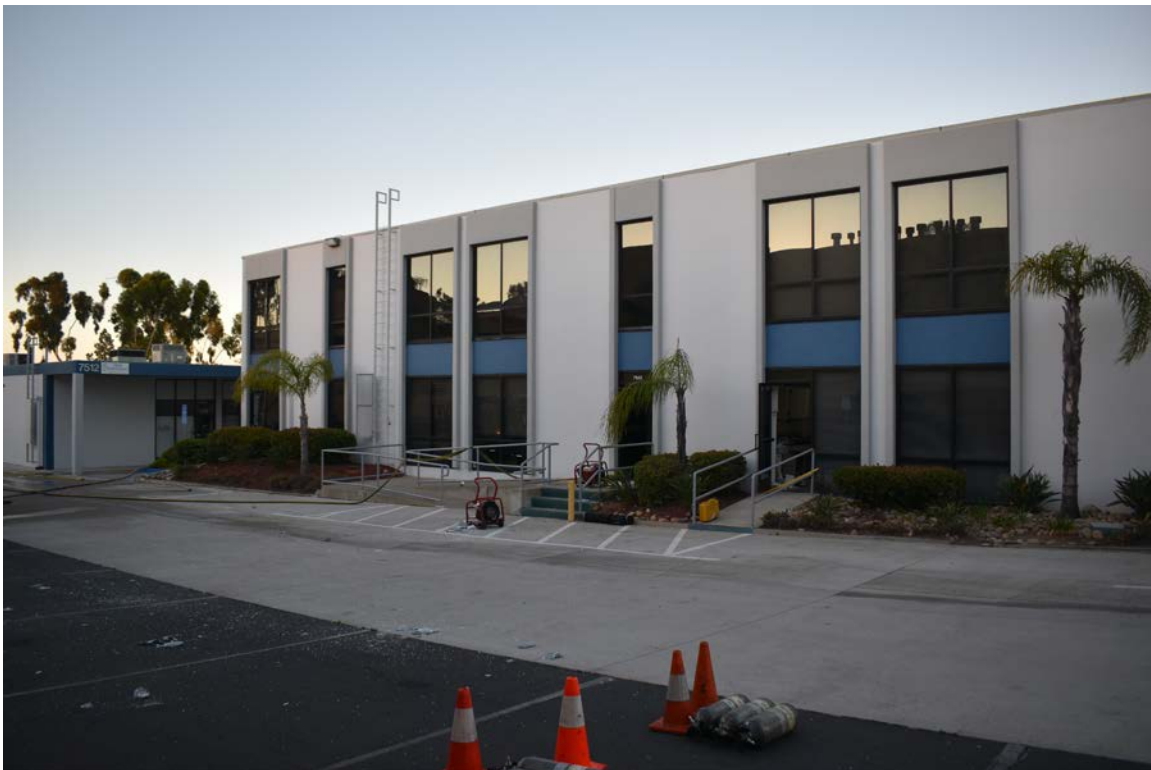
Photo No. 2: Bravo side of structure. Location of event.

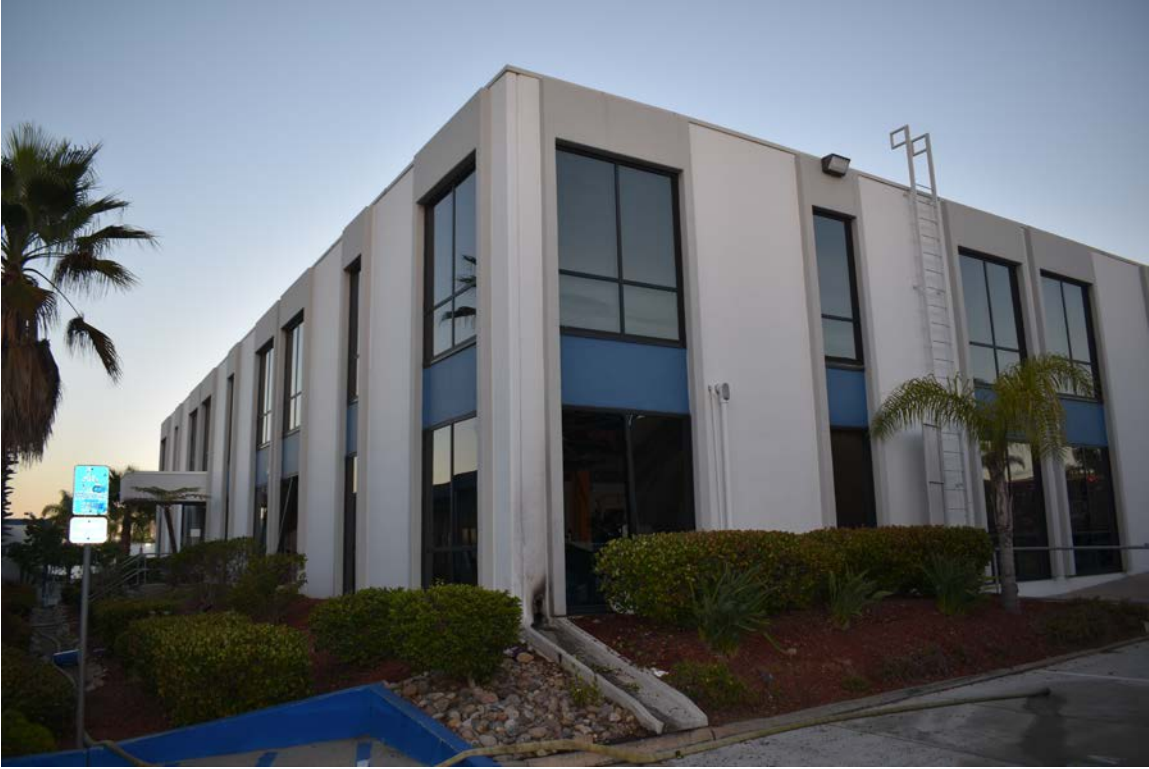
Photo No. 3: Bravo – Charlie corner. Smoke damage from bottom drains.

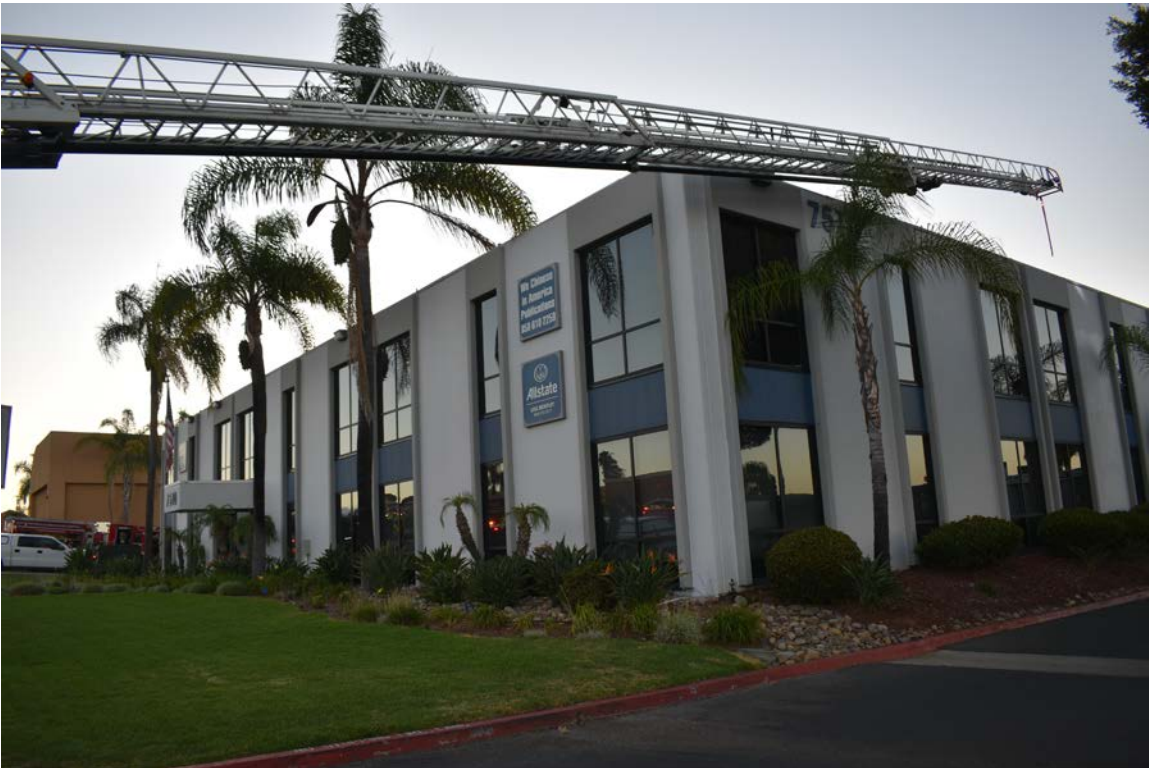
Photo No. 4: Aerial ladder placement at Alpha – Delta Corner

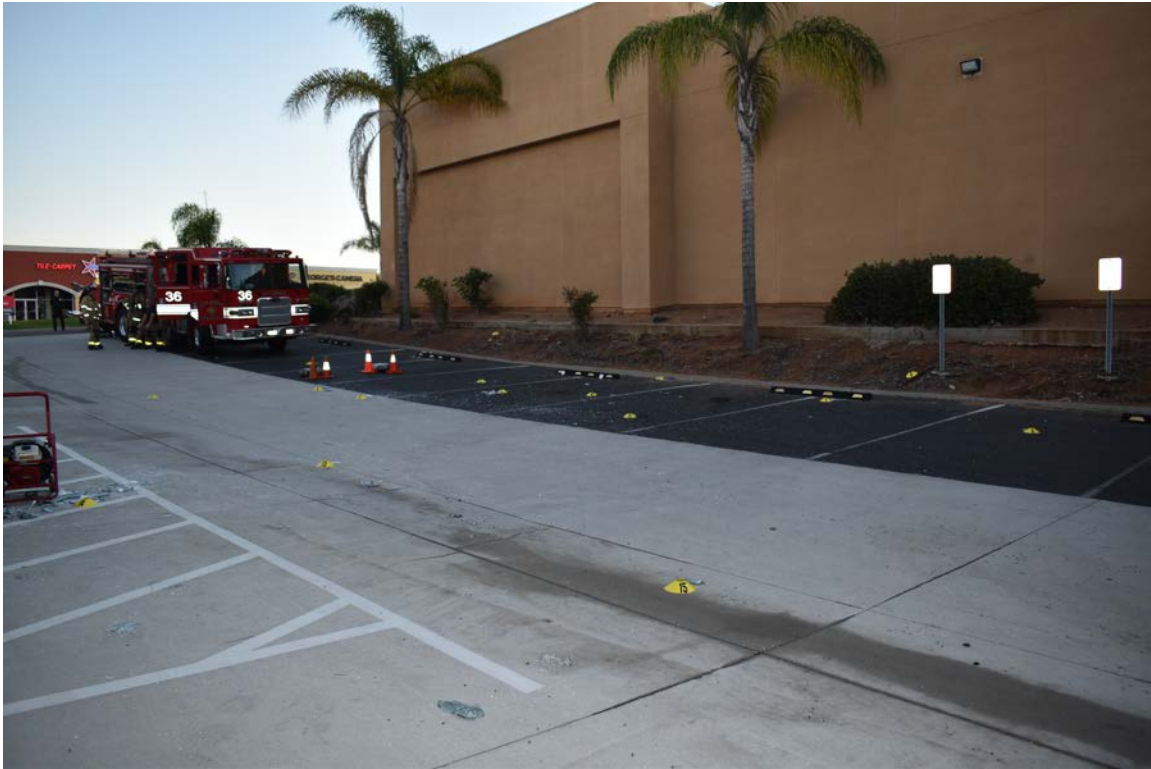
Two firefighters suffered minor superficial injuries resulting from flying tempered glass debris.

Photo No. 5: Tempered glass debris field. Large artifacts marked with yellow cones.

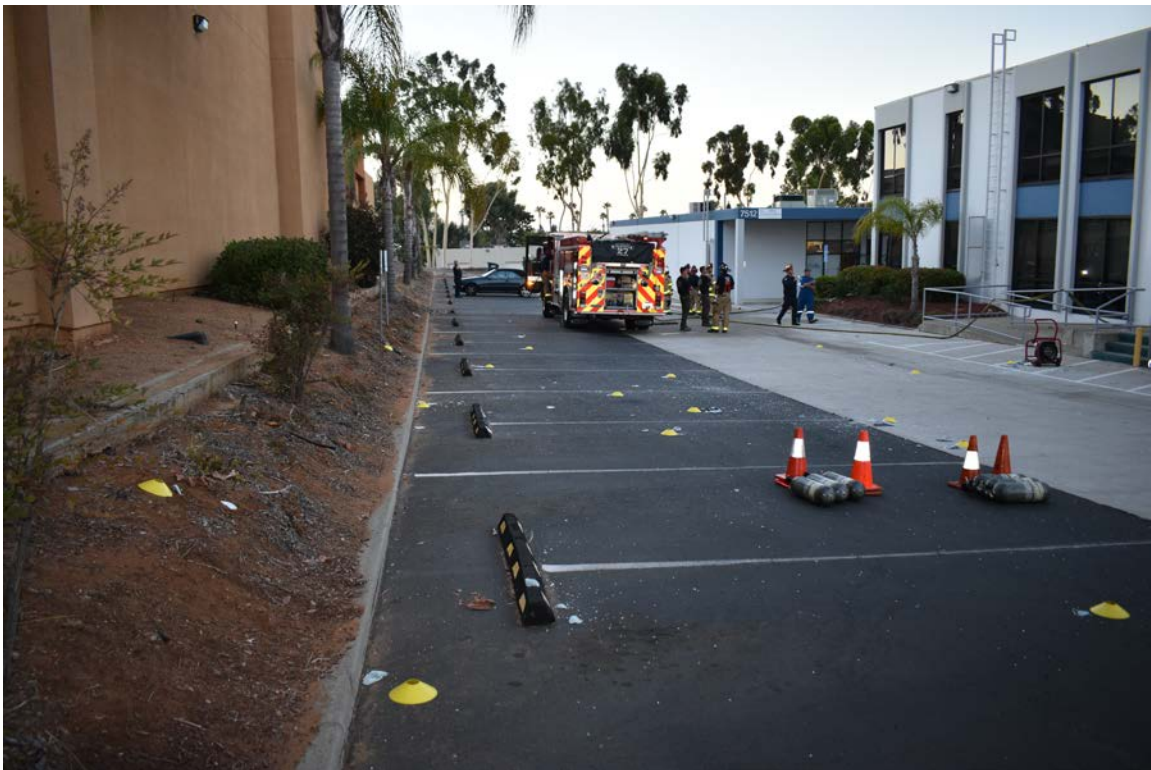
Photo No. 6: Debris field; view from south to north.

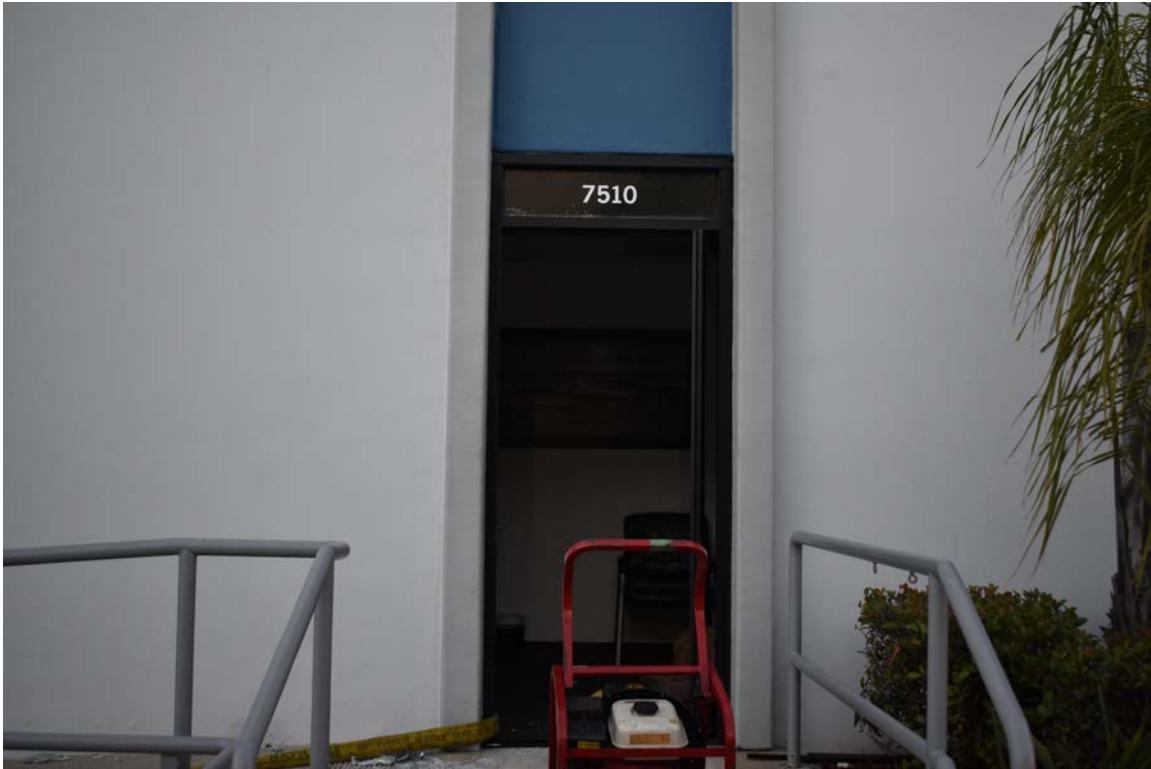
Photo No. 7: Forced door.

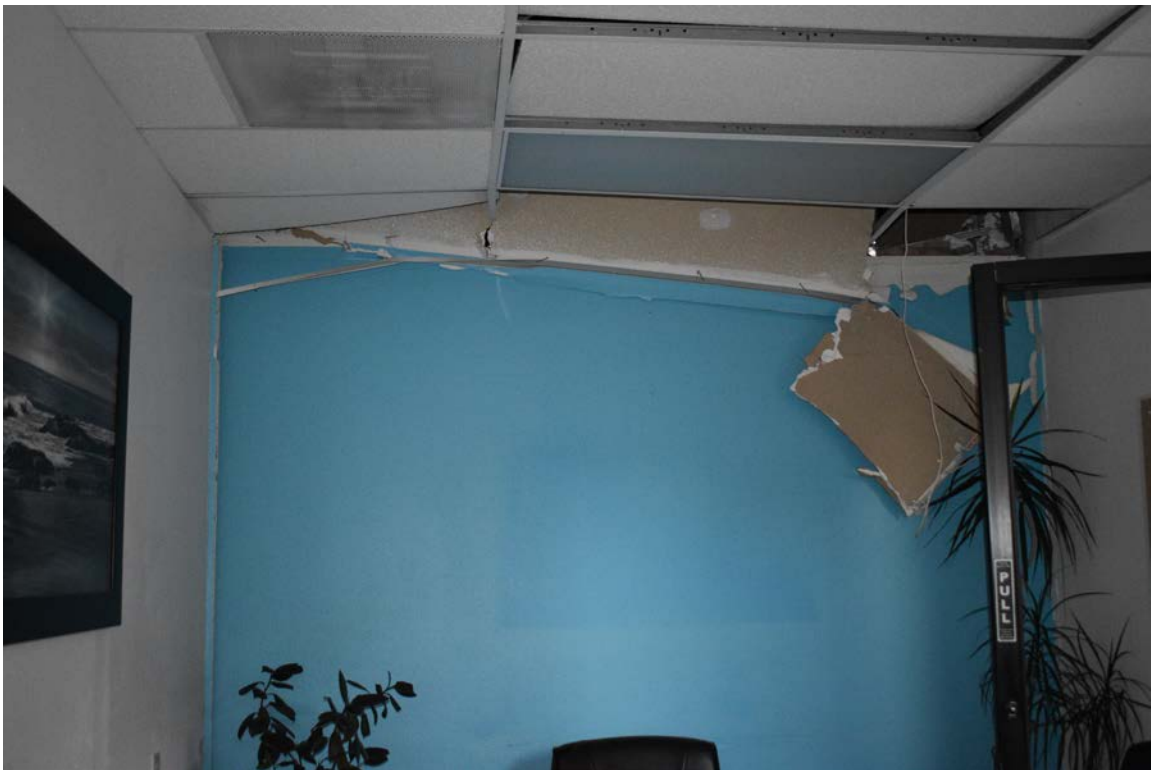
Photo No. 8: High level blast pressure structural damage.

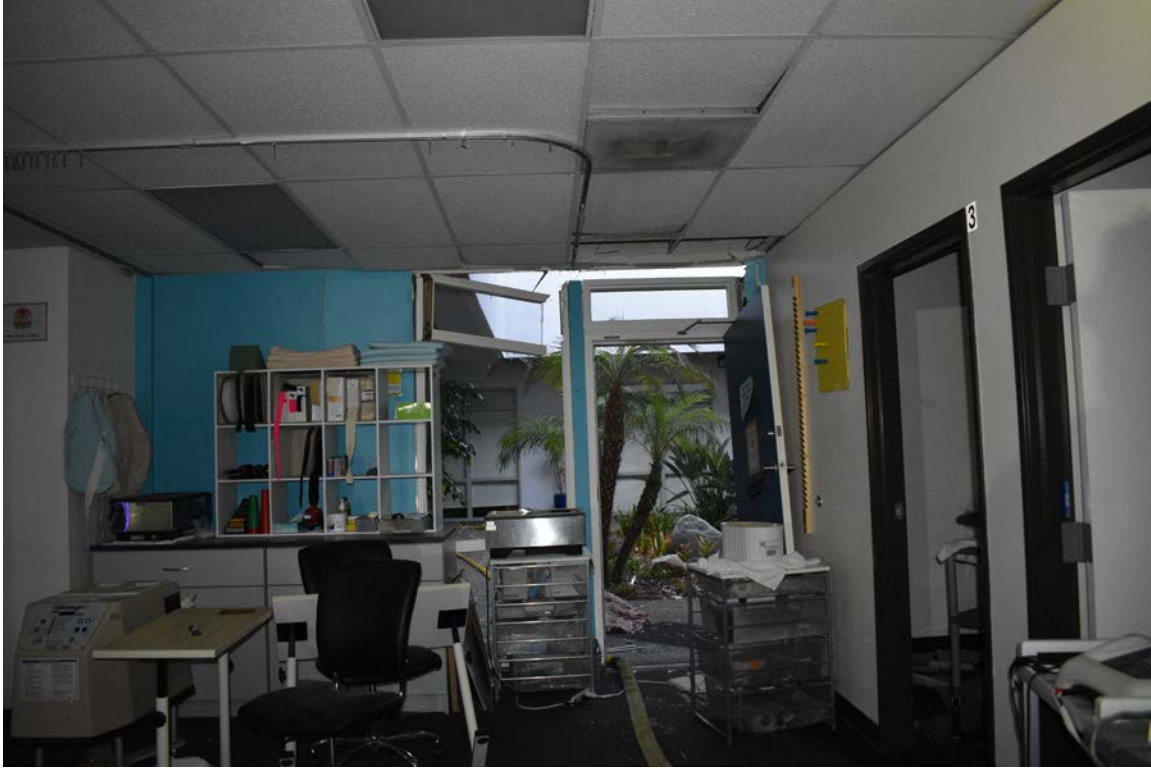
Photo No. 9: Access door to center courtyard. High level severe structural damage.

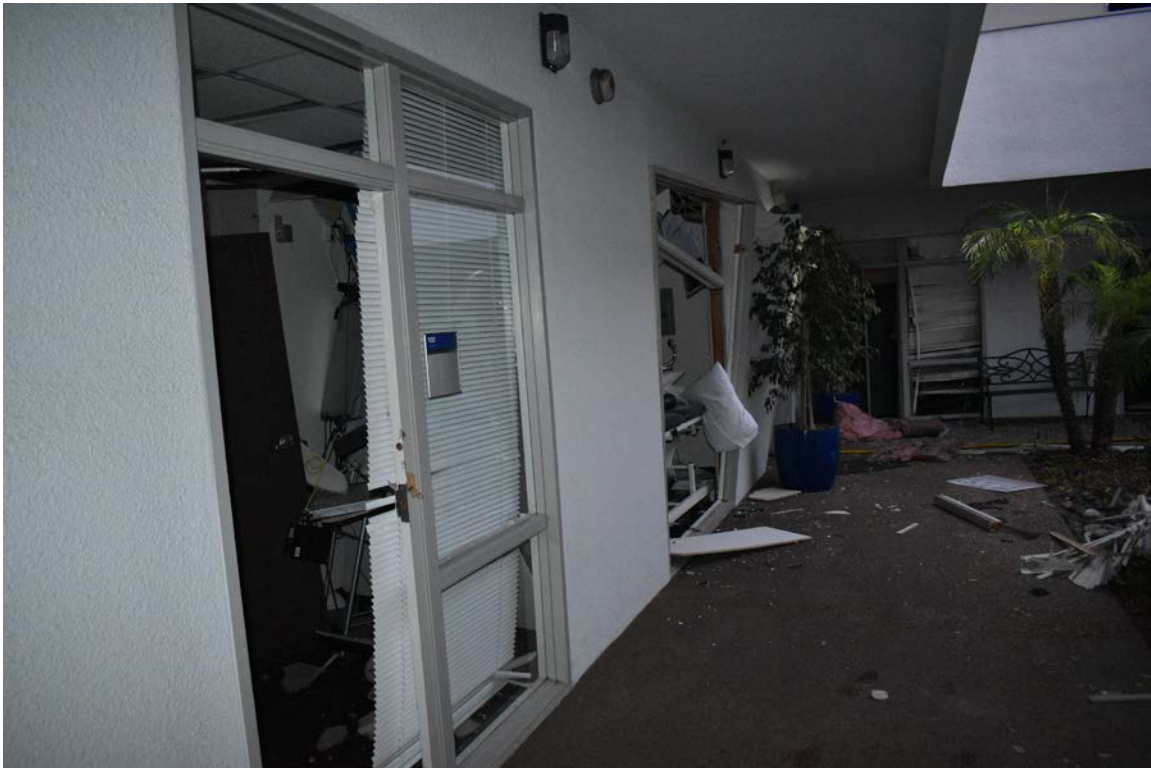
Photo No. 10: Protruding door and window frames; view from center courtyard.

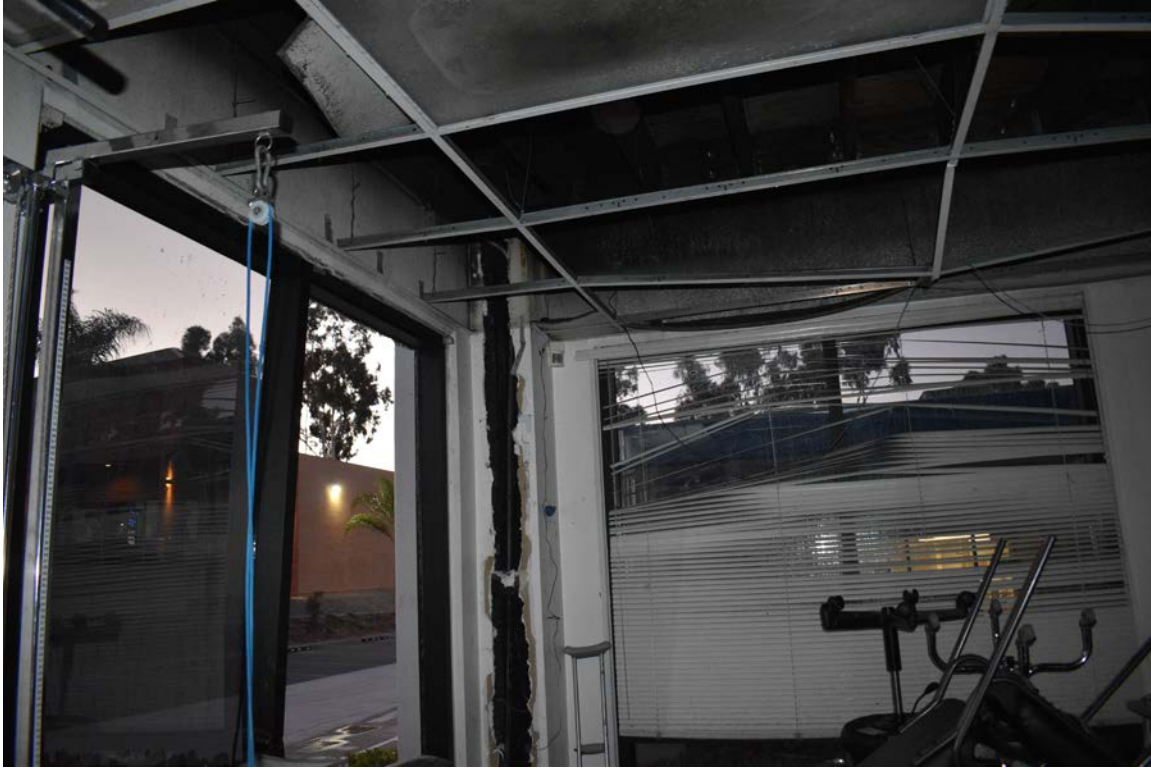
- An electrical event initiated a smoldering fire at an outlet at the bottom of a 1' by 1' vertical chase. Fuels inside the chase included exposed wood framing, ABS piping, and electrical conduit. Fire gases exhausted towards the top of the chase via a rooftop drain and through perforations in a void space between the first-floor ceiling and T-Bar style suspended acoustic panels. By-products of combustion collected in the ceiling void space and chase. A partial volume deflagration occurred when the forcible entry was conducted at the front door of the involved unit, introducing air to a tightly sealed office space.

Photo No. 11: Alpha – Bravo corner; area of origin of fire. ABS pipe and electrical conduit present.

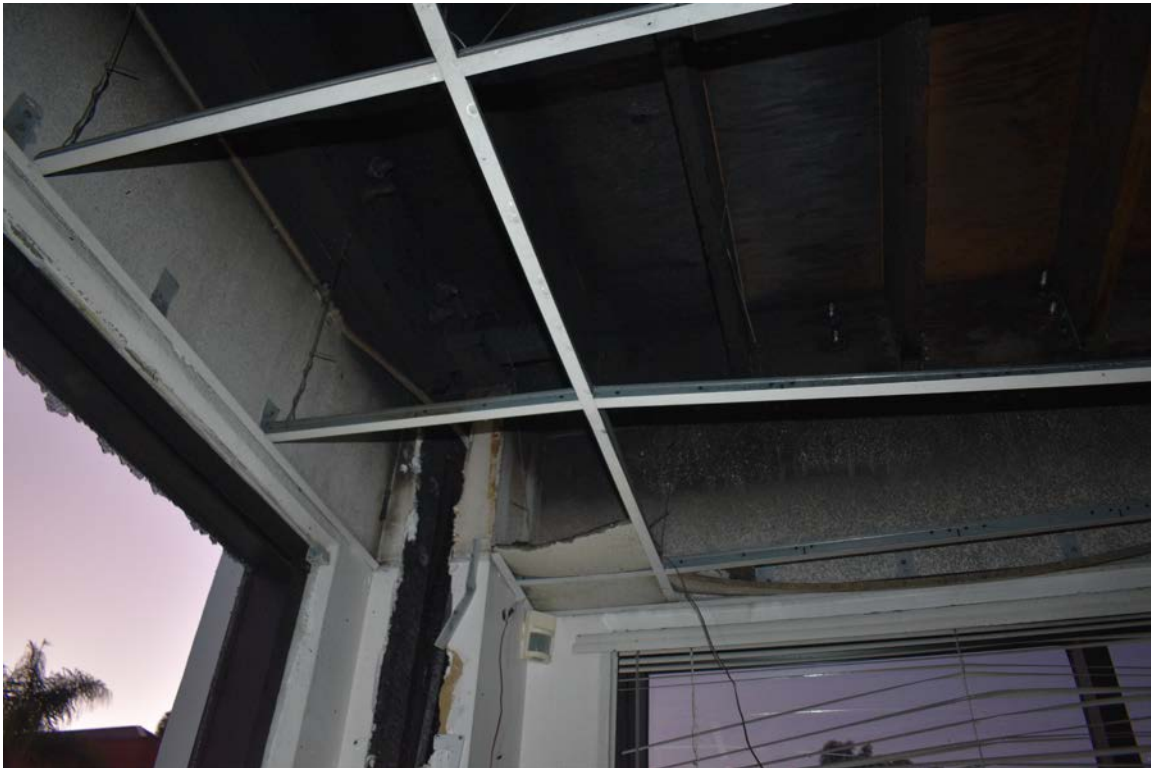
Photo No. 12: Localized smoke staining to plenum between T-bar panels and ceiling.

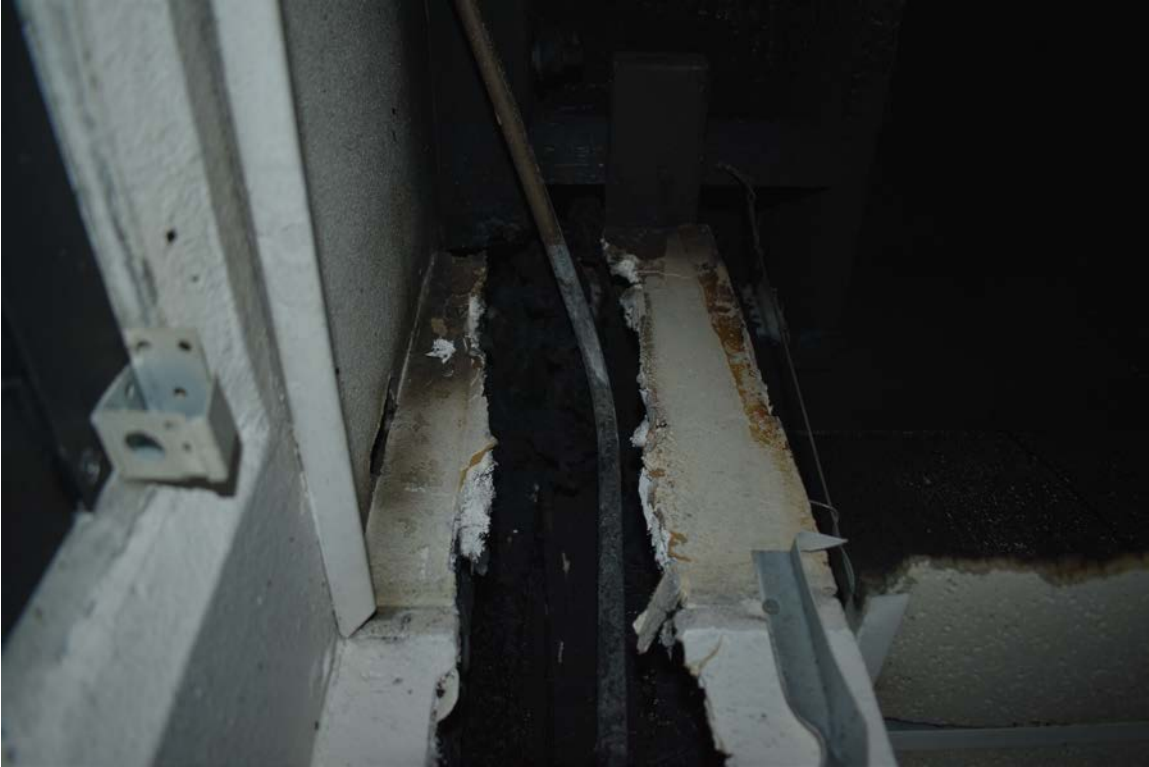
Photo No. 13: Perforation in chase allowing for conduit passage and exhausting of combustion gas

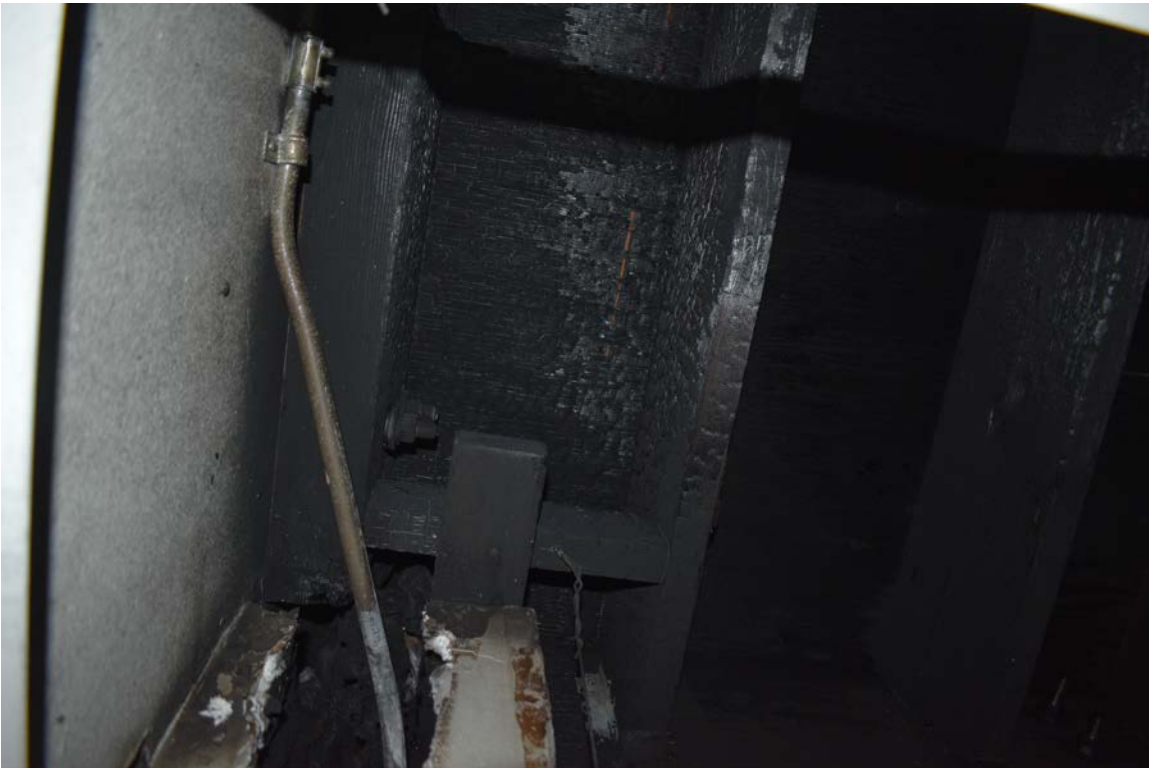
Photo No. 14: Ceiling – Floor Joists above area of origin. Location of escaping combustion gases.

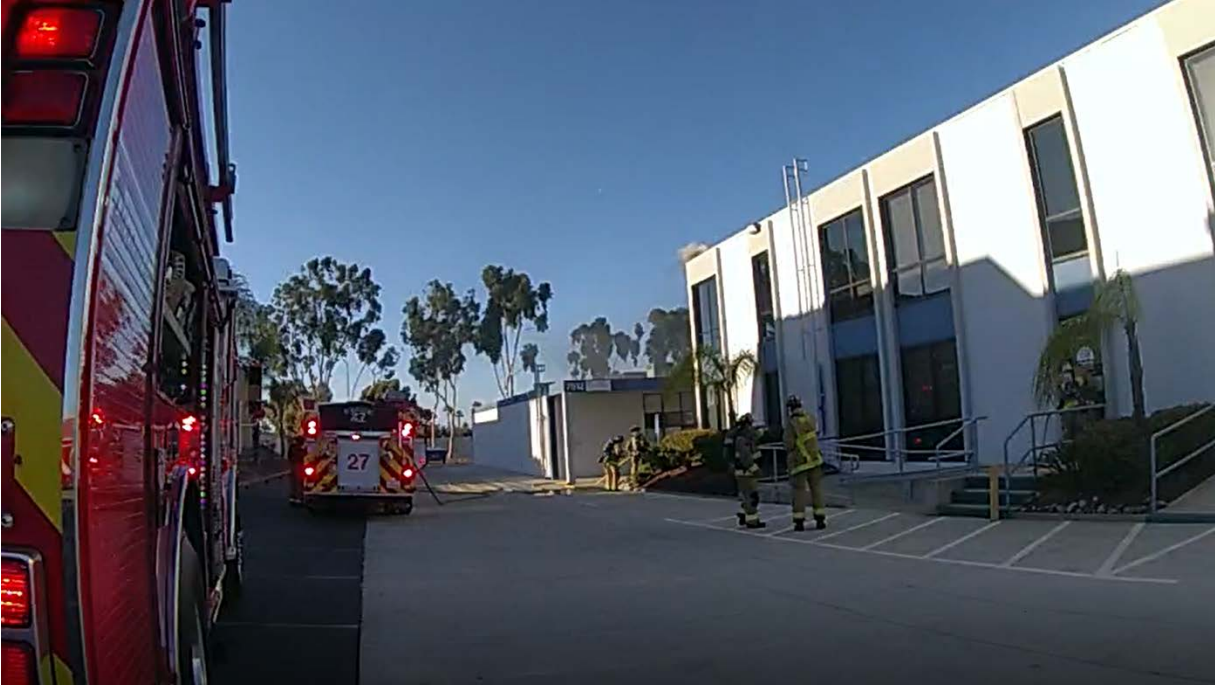
Photo No. 15: View of forcible entry operation at entry door and suppression efforts at B-C corner

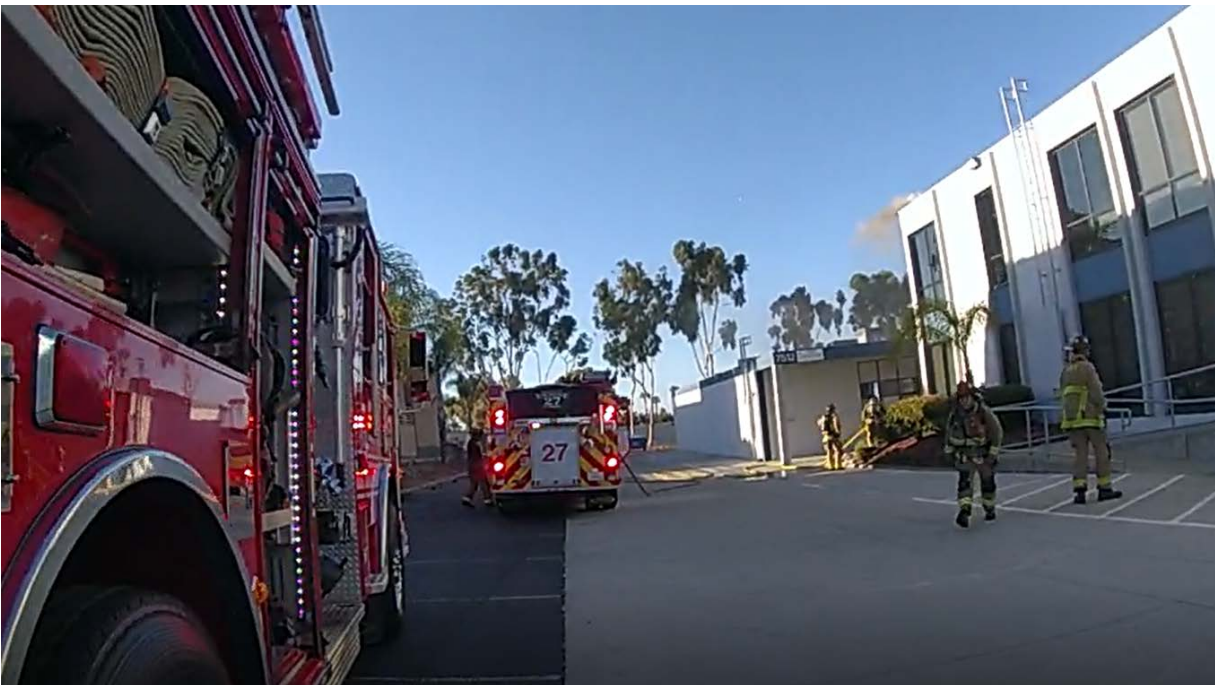
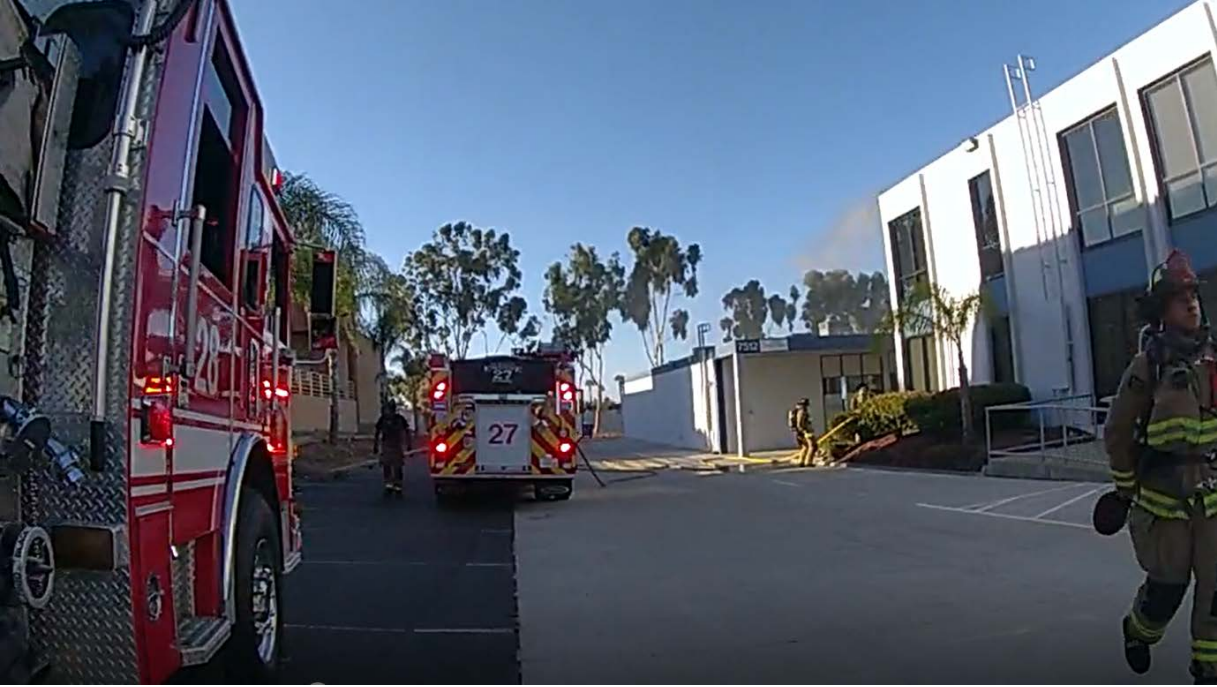
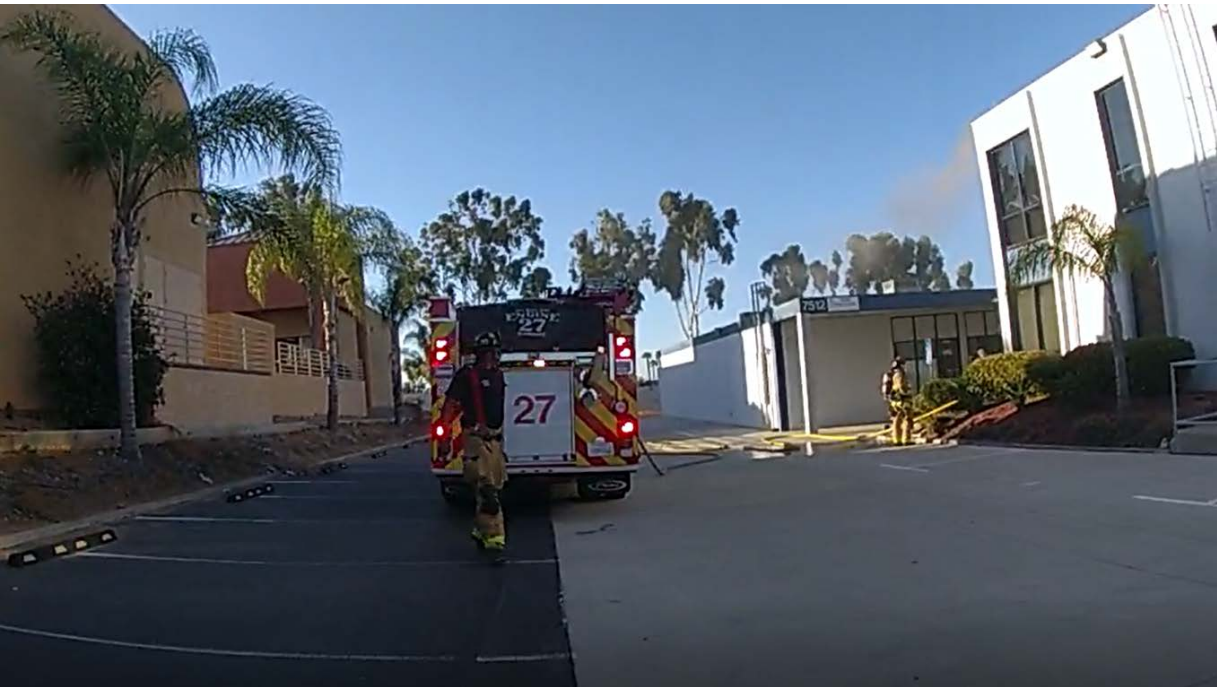
Photo No. 16: View prior to overpressure / deflagration event.

Photo No. 17: View prior to overpressure / deflagration event.

Photo No. 18: View prior to overpressure / deflagration event.

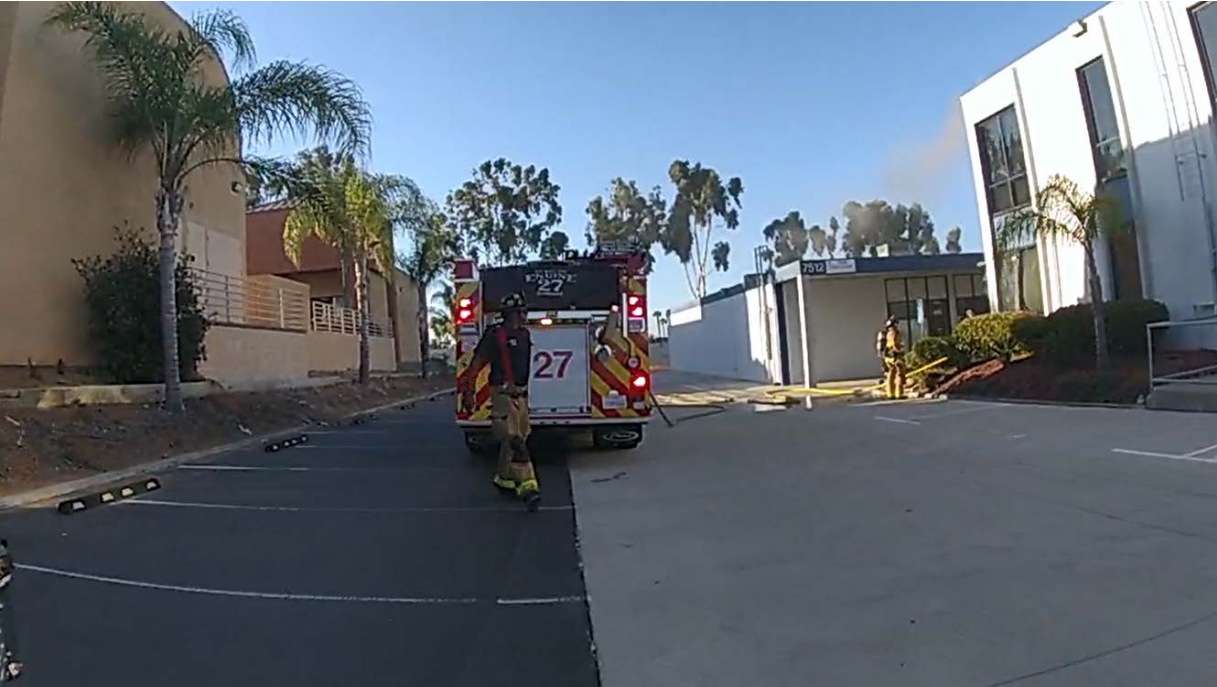
18:39:21 The B/C corner window, on the B side, started bulging outwards

Photo No. 19: Shattering of north first floor window – bowing of blinds in south window

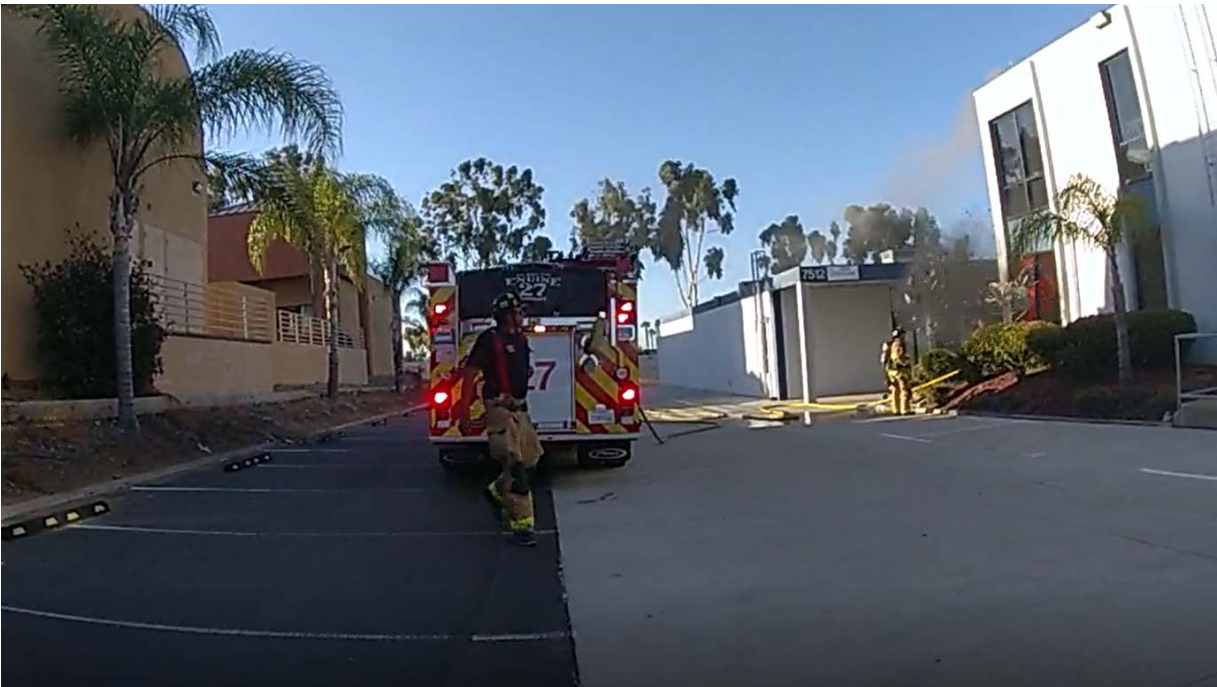
Photo No. 20: Failed window debris with deflagration.

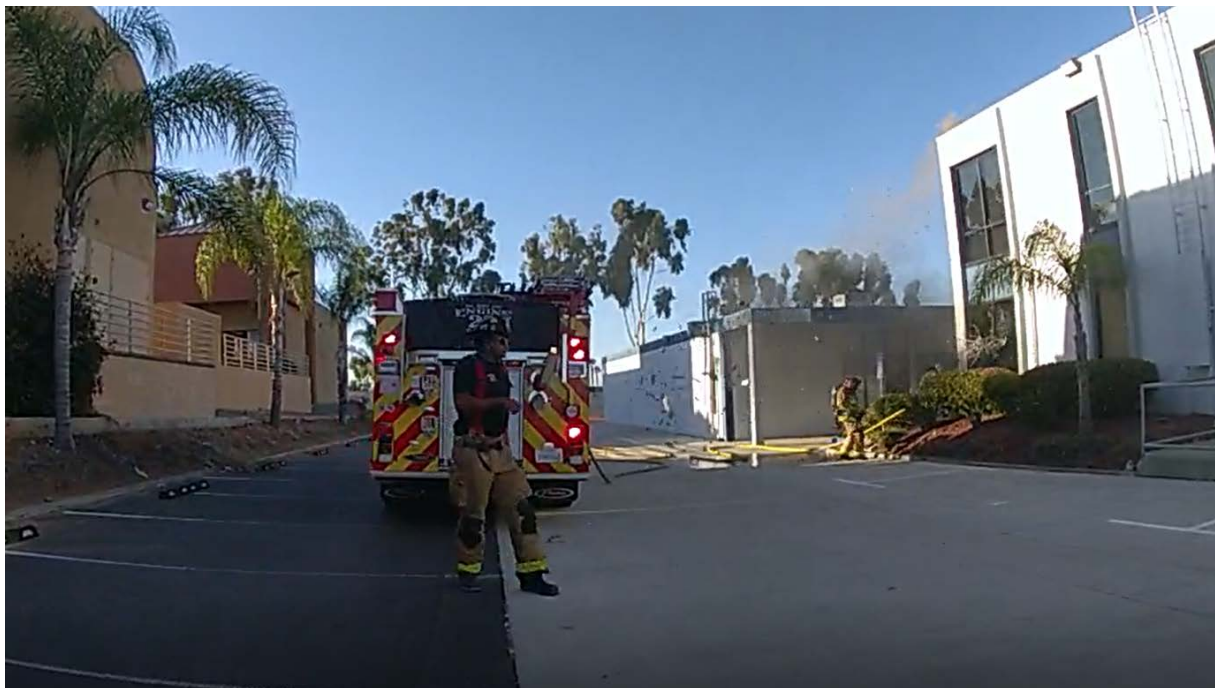
18:39:22 An explosion occurred with a flash of fire which caused the B-side and C-side windows to fail and shatter outward. The B-side glass door also failed and shattered outward. All personnel backed away from the building once the explosion occurred.

Photo No. 21: Debris expelled due west from north window; south window shattering.

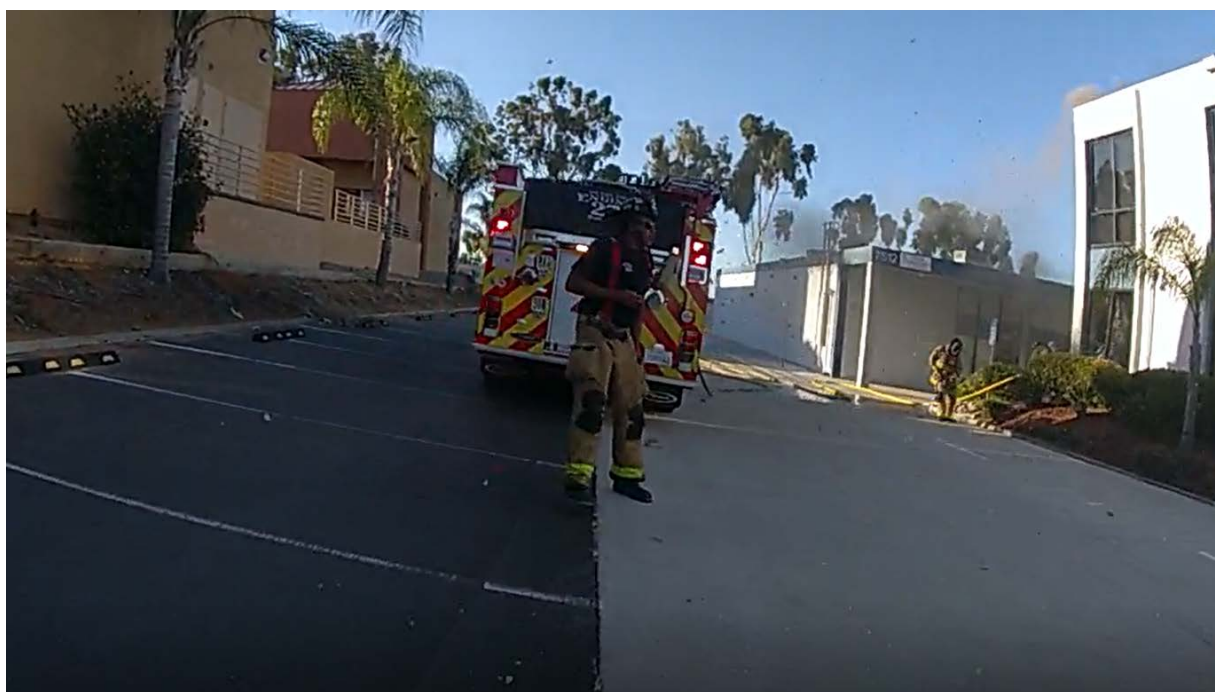
Photo No. 22: Immediate post blast.
