Fire Ground Survival

Chapter 1: Preventing the Mayday

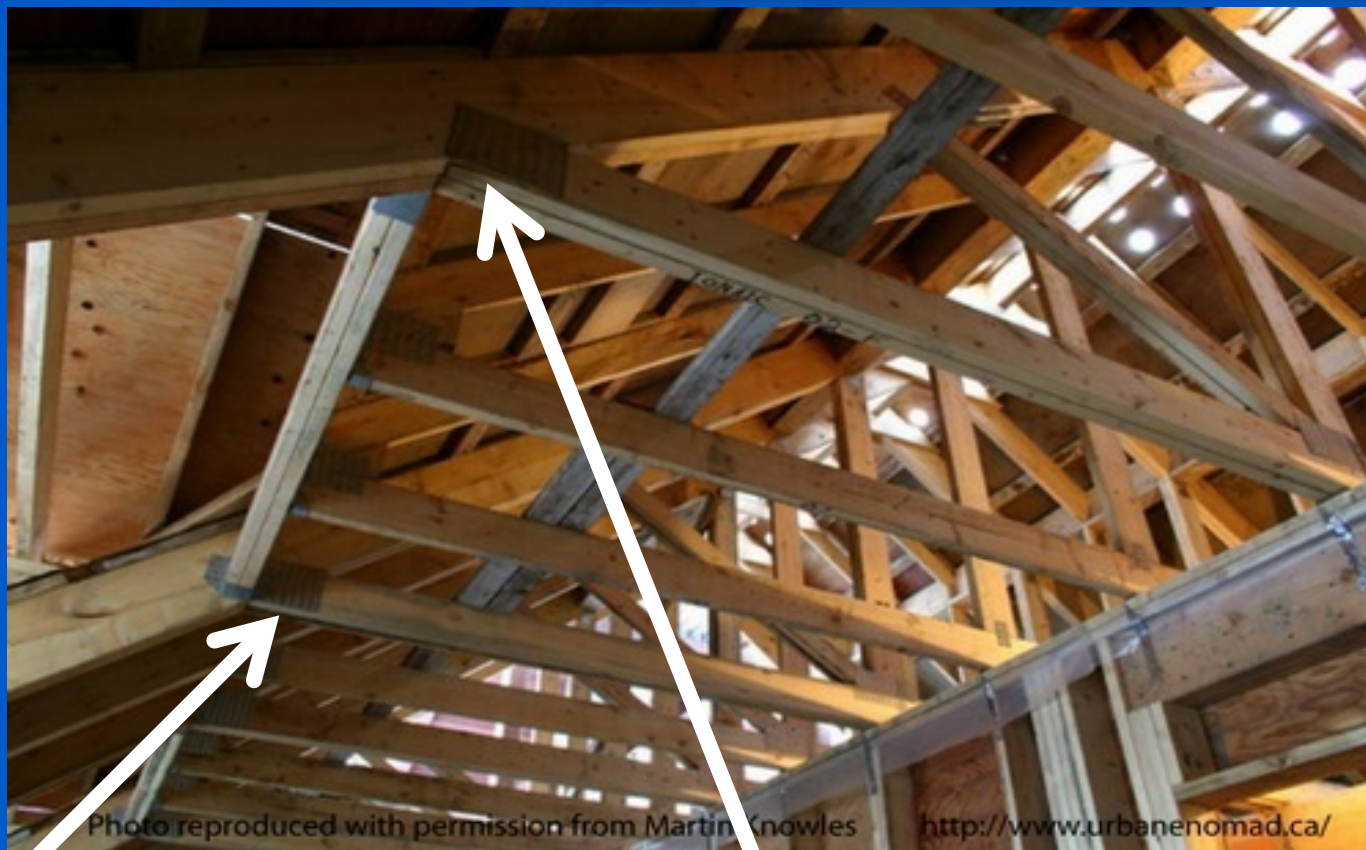
- Trusses fail at the connection points.
- More connection points = more failure points.

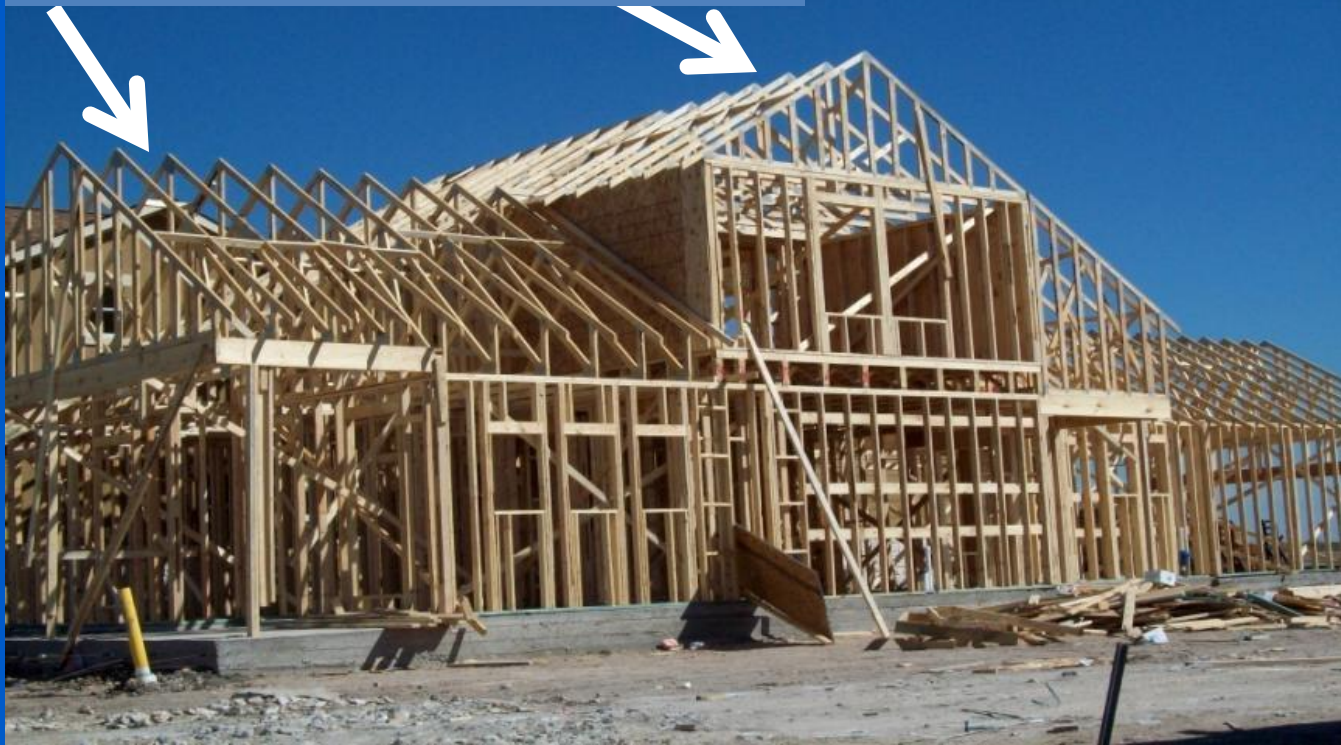
No ridge board = light weight truss

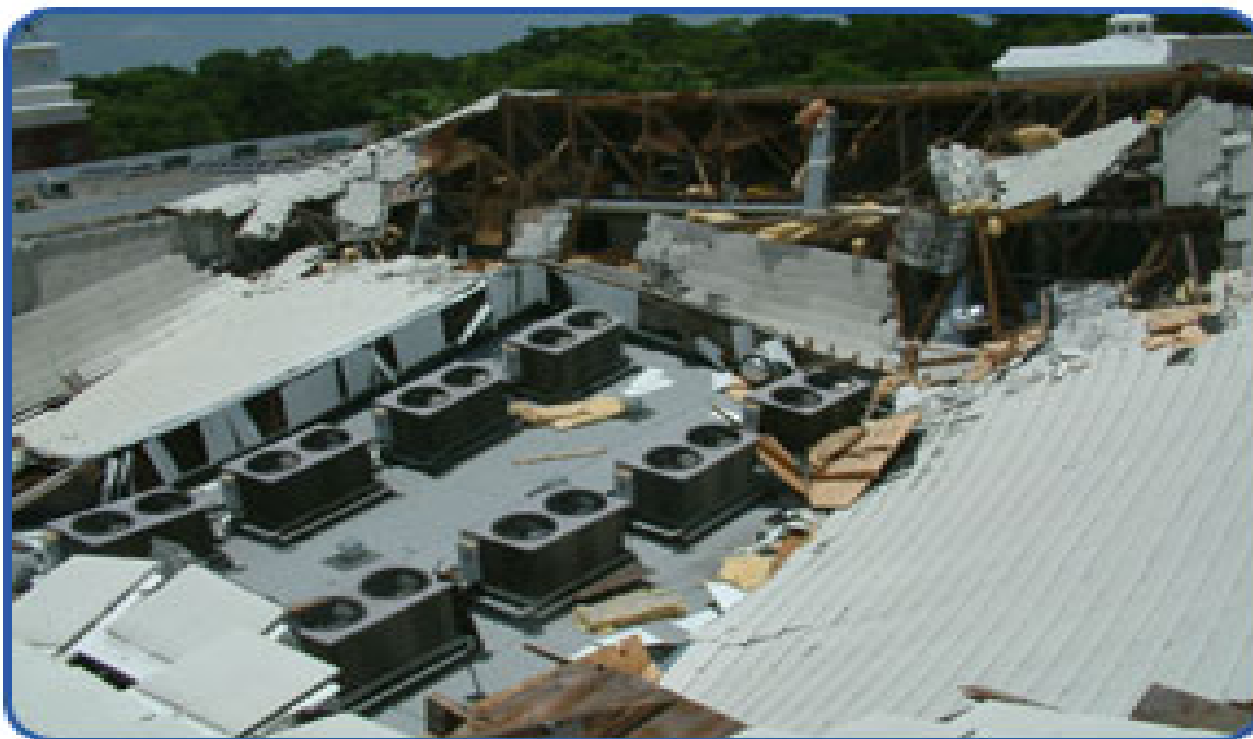
Overhead Weight

**Fire + light-weight truss + overhead weight =
EARLY COLLAPSE**

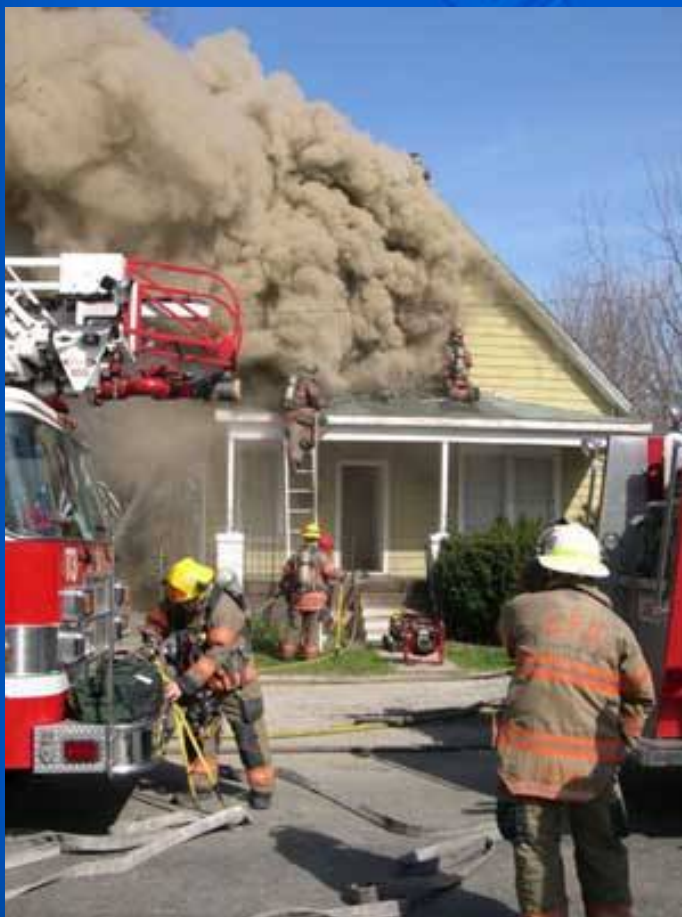
Brown Smoke

- Brown smoke occurs during mid to late stage heating of Unfinished wood
- Observing brown smoke venting from void spaces in the floors, walls, ceilings or roof is an indicator that structural components are being heated and compromised— **Be on guard for collapse!**

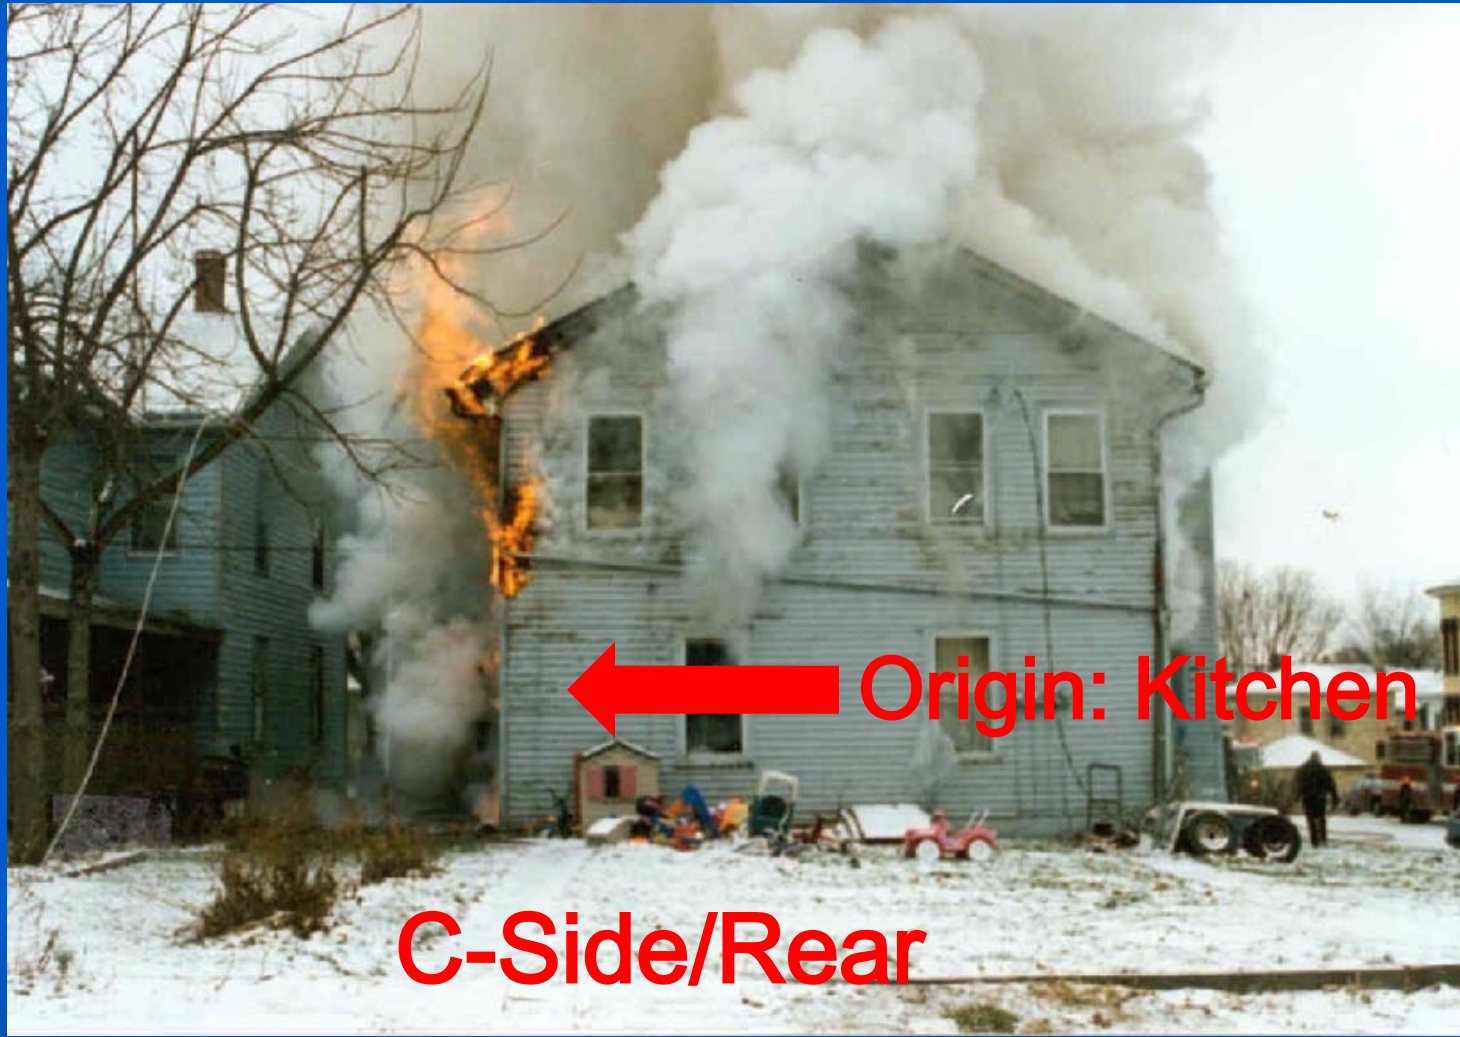
← Origin: Kitchen

C-Side/Rear

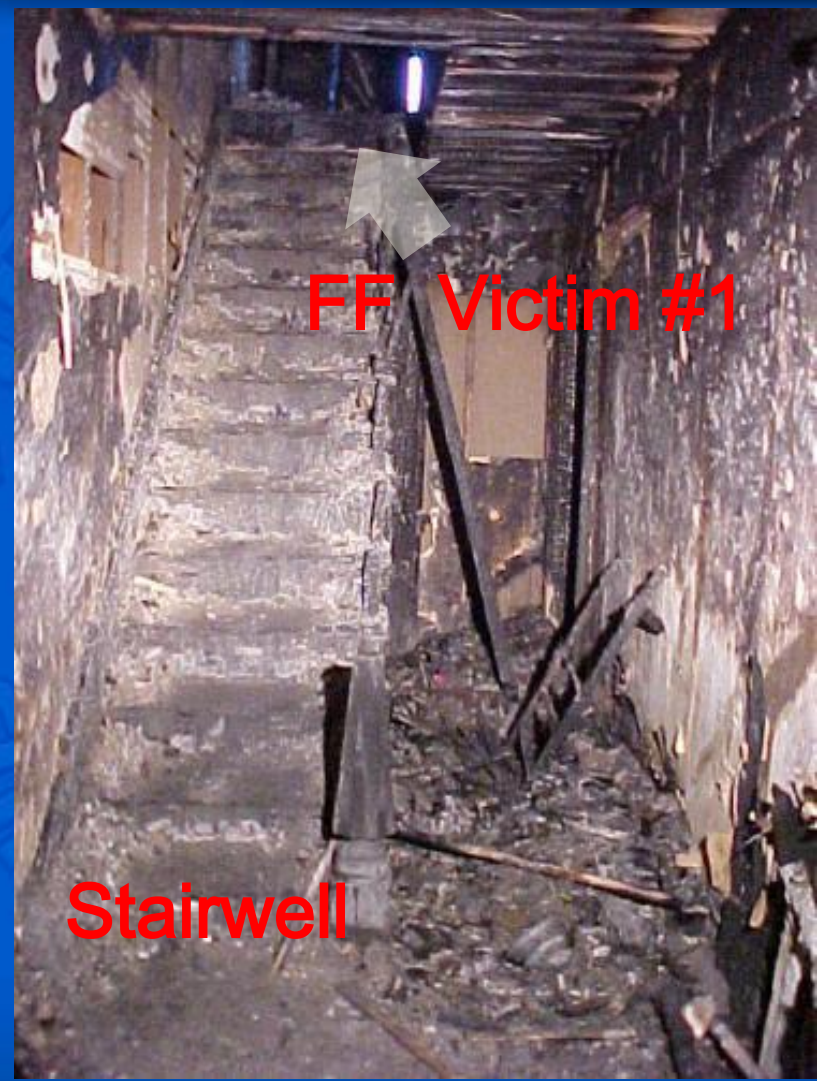
FF Victim #1

Stairwell
